STATE OF UTAH MSE WALL INSPECTION FORM

Compiled As Part of Research By The Utah Department of Transportation

Inspection Date	8/01/2017	Names Of Inspectors	RYAN & HOLY
Region	2	Identifying Road/Intersection	BANHETER : I-15

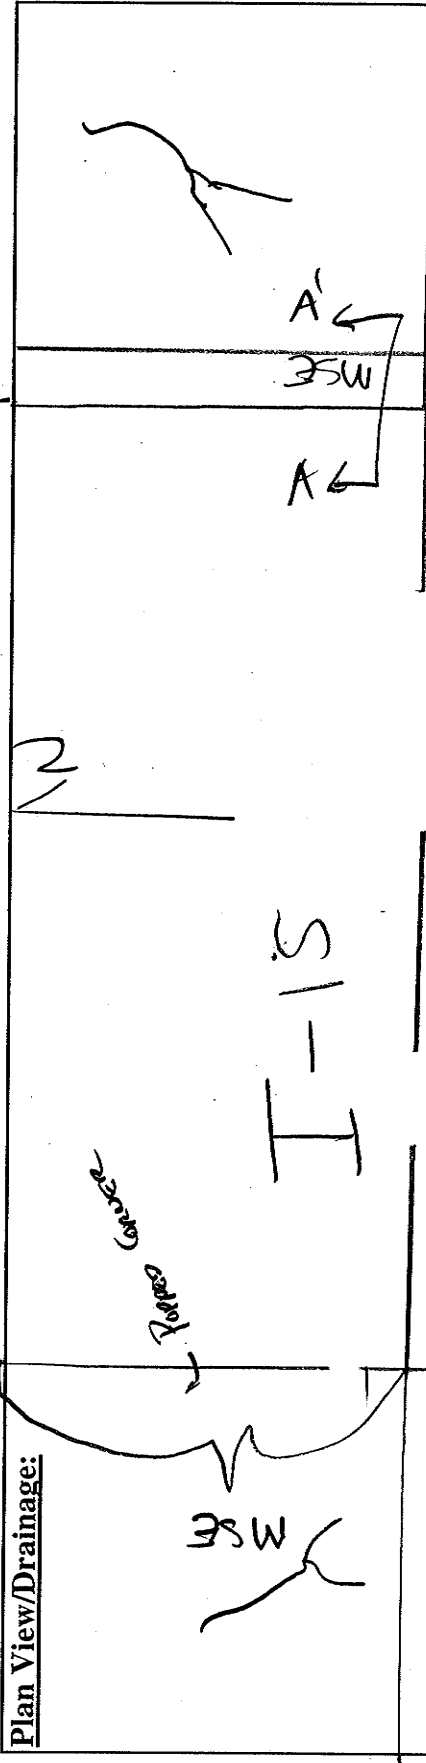
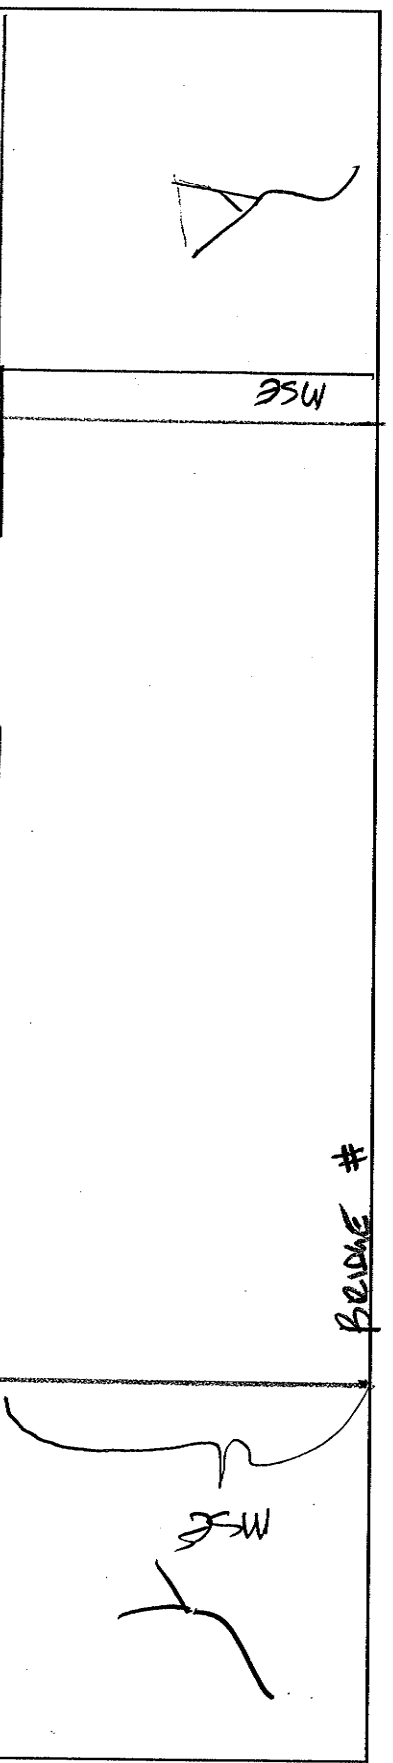
Plan View/Drainage:

- NEW WALL IN VERY GOOD CONDITION
- MSE SECTION SERVES AS A NINE WALL (ON SIDES) OF CAST IN PLACE CONCRETE WALL @ ABUTMENT
