STATE OF UTAH MSE WALL INSPECTION FORM

Compiled As Part of Research By The Utah Department of Transportation

Region	3	Identifying Road/Intersection Provo Canyon, riverside #1 (B.V.F)

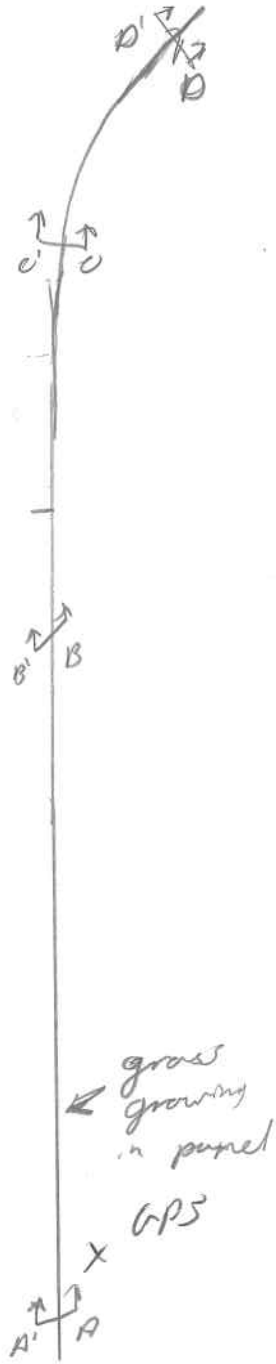
Plan View/Drainage:

vegetation in wall panels
