# STATE OF UTAH MSE WALL INSPECTION FORM

Compiled As Part of Research By The Utah Department of Transportation

<b>Region</b>	3	<b>Identifying Road/Intersection</b>	Port canyon river side #2 (R.V.P)
---------------	---	--------------------------------------	-----------------------------------

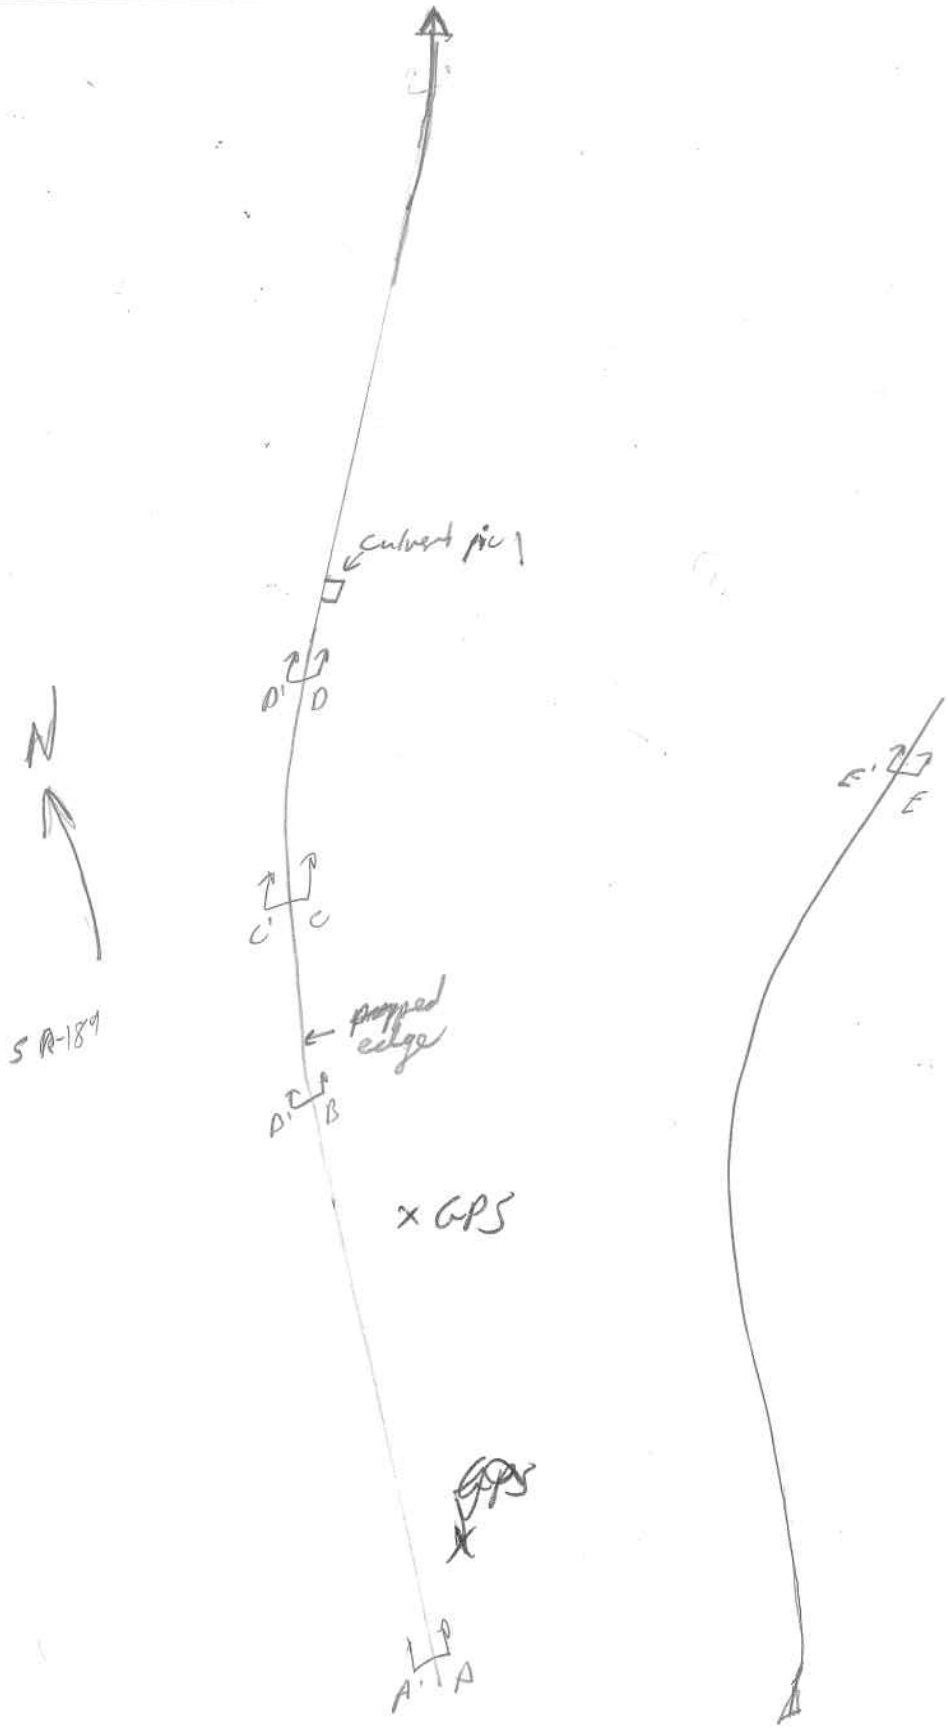
Plan View/Drainage:

looks good, but lots of vegetation at the base of the wall  
possible water damage from SR-189
