STATE OF UTAH MSE WALL INSPECTION FORM

Compiled As Part of Research By The Utah Department of Transportation

Region	4	Identifying Road/Intersection	SR-9, Hurricane

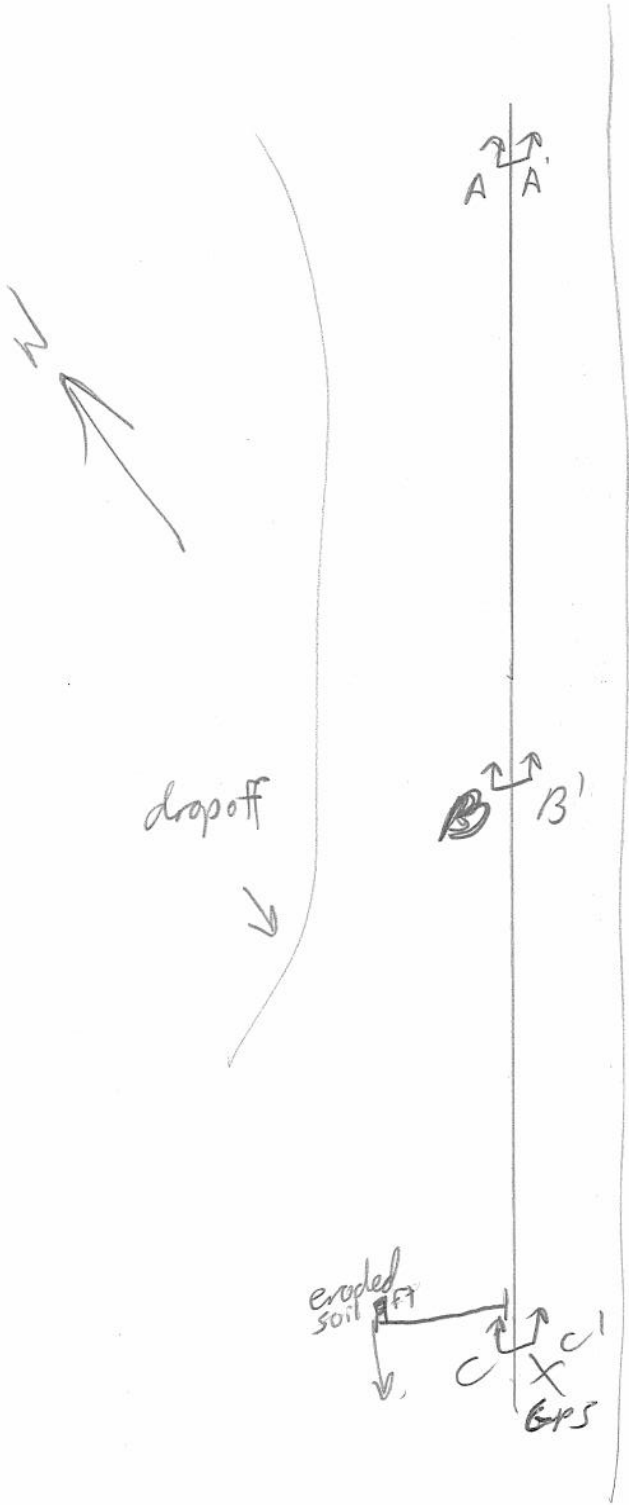
Plan View/Drainage:

soil slopes off to a lava rock drop-off
 wall condition looks good
 drains on west end, soil erosion on west end
