STATE OF UTAH MSE WALL INSPECTION FORM

Compiled As Part of Research By The Utah Department of Transportation

Inspection Date	7/25	Names Of Inspectors	Ryan maw, Hollygriffin
Region	1	Identifying Road/Intersection	US-91/89 and Mantua

MSE Wall at Bridge	Y N	Bridge Number if applicable:	E-578	Wall Number	R-276
Surrounding Structures	Cantilever wall - 40 ft.		Maximum Height of Wall (ft)	20ft	
Distance to Each Structure	40ft. across road		One Stage, Two Stage or Block Wall	one stage	
State Route Number	SR-91/89		Estimated Max Length of Wall Abutment:	330' 330'	
Approximate Mile Marker	6		Max Slope of Ground in front of wall:	0'	
GPS Datum	WGS/84 NAD/83, or NAD/27		Max Height of wall burial line above surrounding level ground:	20ft 4in	
MSE Wall GPS Coordinates (Location of Measurement shown on plan view)	N 41° 29.868		Please draw rough layout of panel with approximate dimensions in space provided below:		
	W 111° 57.223				
If known, Panel or System Manufacturer	VSL VSL		58 x 65

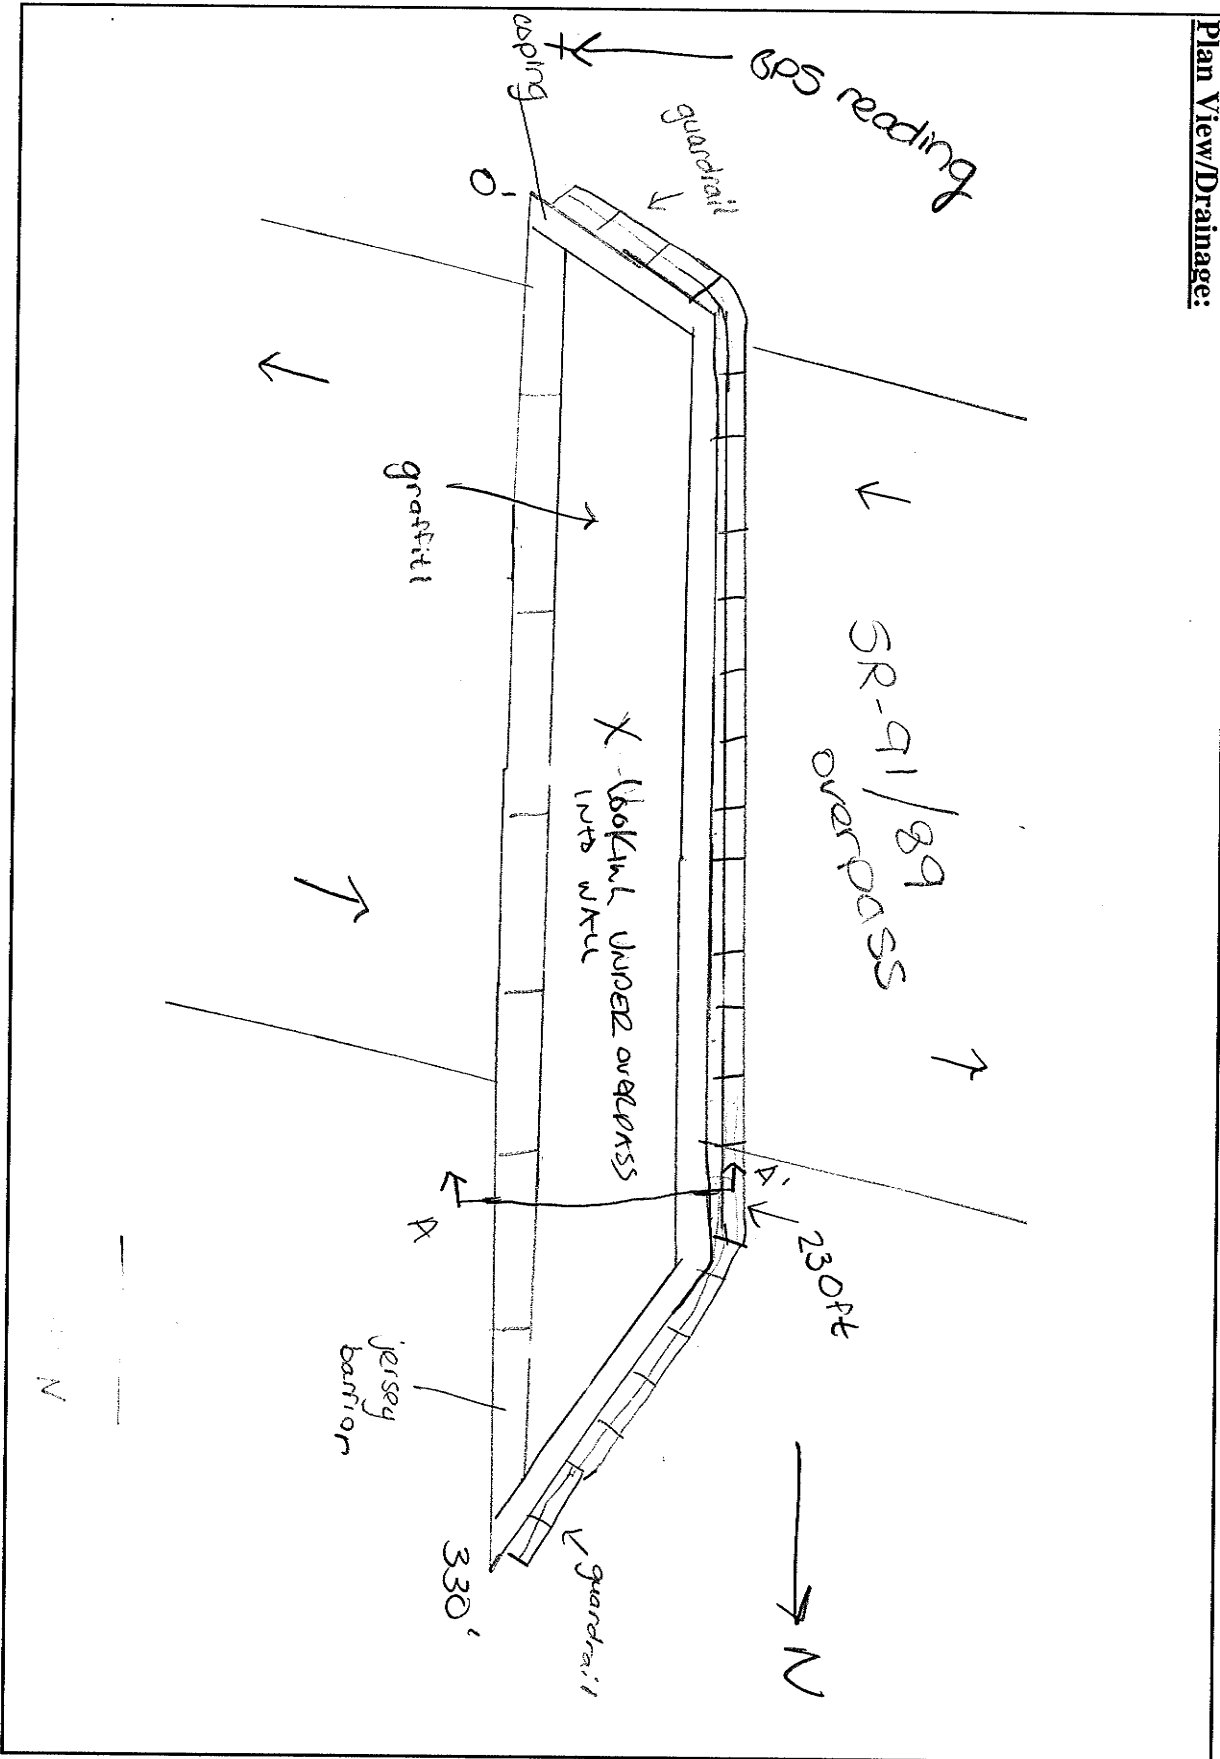
Plan View/Drainage:

vertical drain partially blocked
corrosion of metal guardrail
