# STATE OF UTAH MSE WALL INSPECTION FORM

Compiled As Part of Research By The Utah Department of Transportation

<b>Region</b>	3	<b>Identifying Road/Intersection</b>	Provo Canyon, <sup>east</sup> west side
---------------	---	--------------------------------------	---

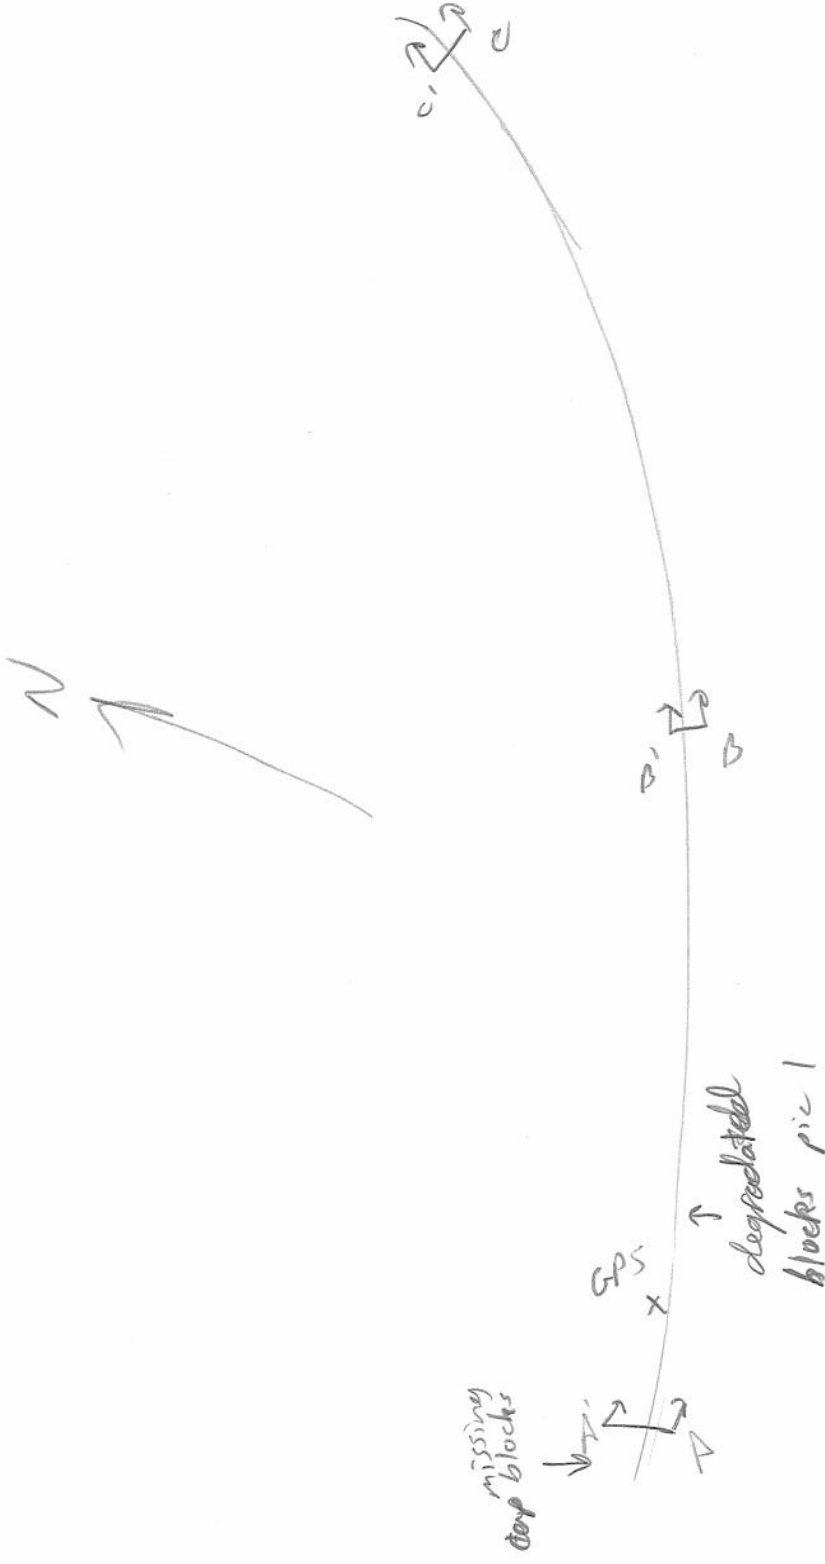
Plan View/Drainage:

lots of trash in front of wall
