STATE OF UTAH MSE WALL INSPECTION FORM

Compiled As Part of Research By The Utah Department of Transportation

Region	3	Identifying Road/Intersection	<i>Provo Canyon, south side</i>
---------------	---	--------------------------------------	---------------------------------

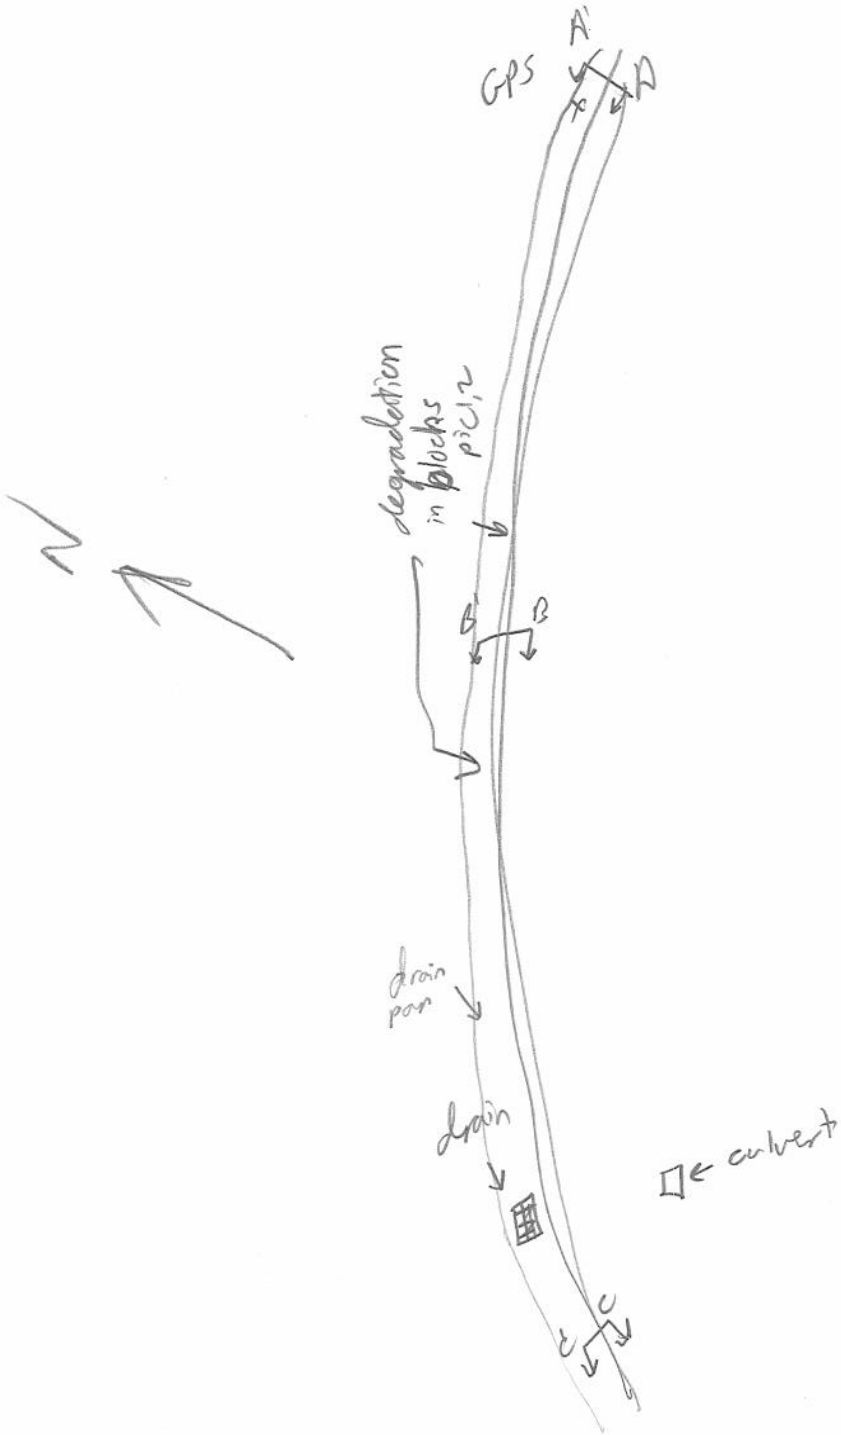
Plan View/Drainage:

Summary of Key Observations:

Top blocks eroded away
