# STATE OF UTAH MSE WALL INSPECTION FORM

Compiled As Part of Research By The Utah Department of Transportation

<b>Region</b>	2	<b>Identifying Road/Intersection</b>	E-15, 600 N, SLC
---------------	---	--------------------------------------	------------------

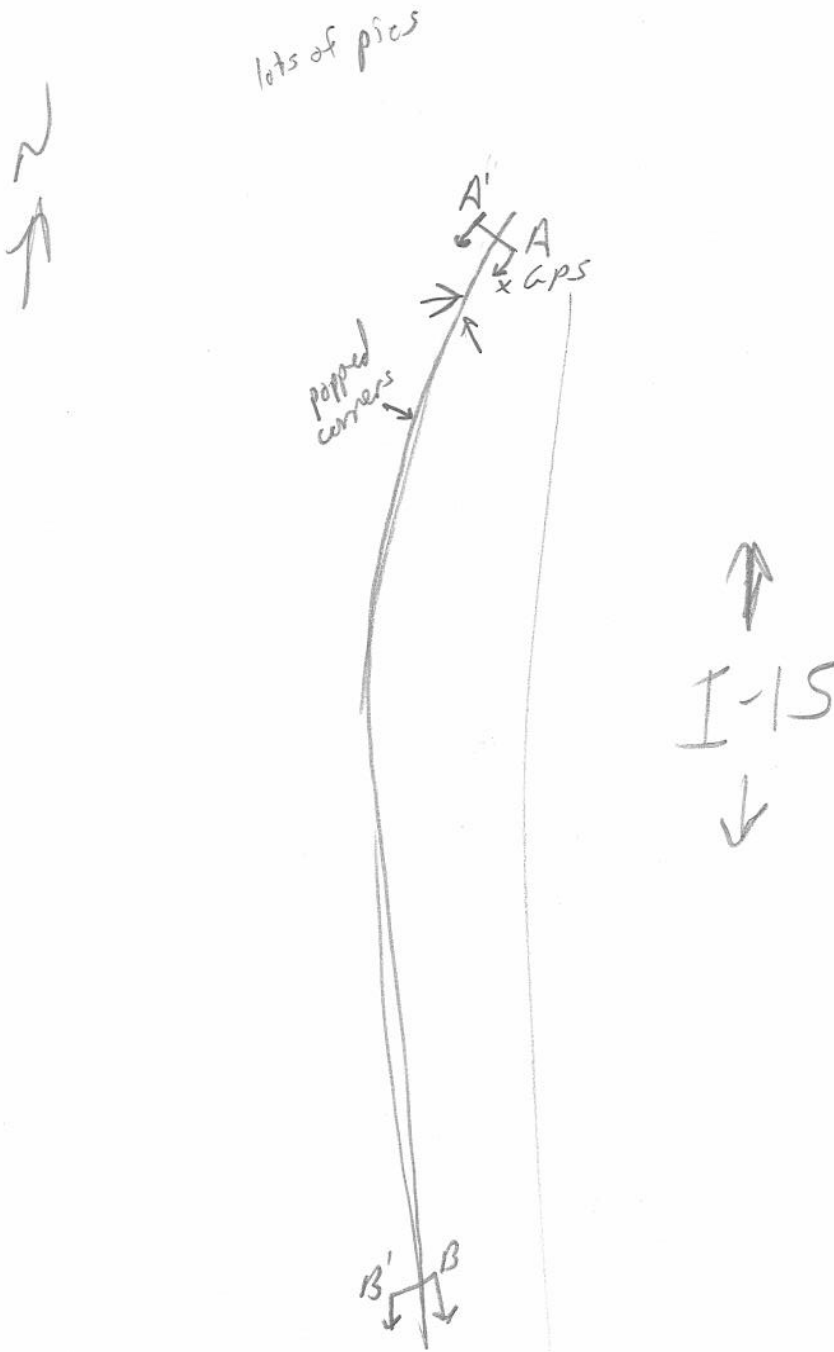
Plan View/Drainage:

sagging approach, coping settling
