# STATE OF UTAH MSE WALL INSPECTION FORM

Compiled As Part of Research By The Utah Department of Transportation

2		I-15, 600 ft, SLC
<b>Region</b>		<b>Identifying Road/Intersection</b>

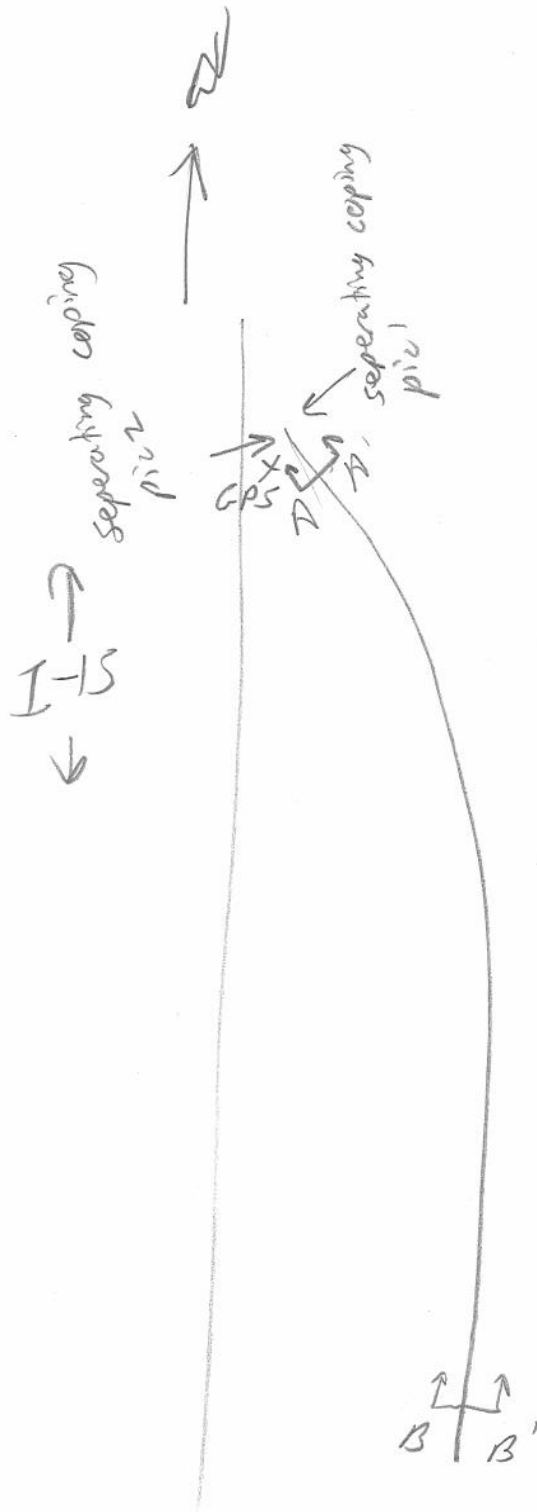
Plan View/Drainage:

Coping settled near bridge
