# STATE OF UTAH MSE WALL INSPECTION FORM

Compiled As Part of Research By The Utah Department of Transportation

<b>Region</b>	~	<b>Identifying Road/Intersection</b>	I-15, 600 N, SLC
---------------	---	--------------------------------------	------------------

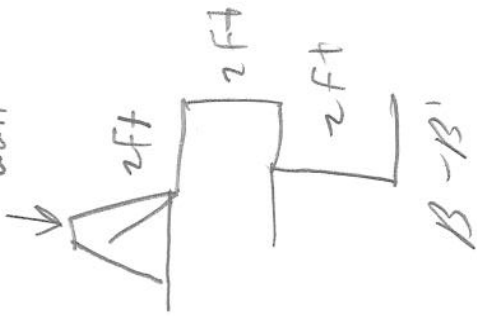
CIP  
Wall

Large chunk of concrete popped off from concrete barrier suggesting that soil is unable to support the load placed on it
