STATE OF UTAH MSE WALL INSPECTION FORM

Compiled As Part of Research By The Utah Department of Transportation

I-15, 660 N, SLC
Region	2	Identifying Road/Intersection

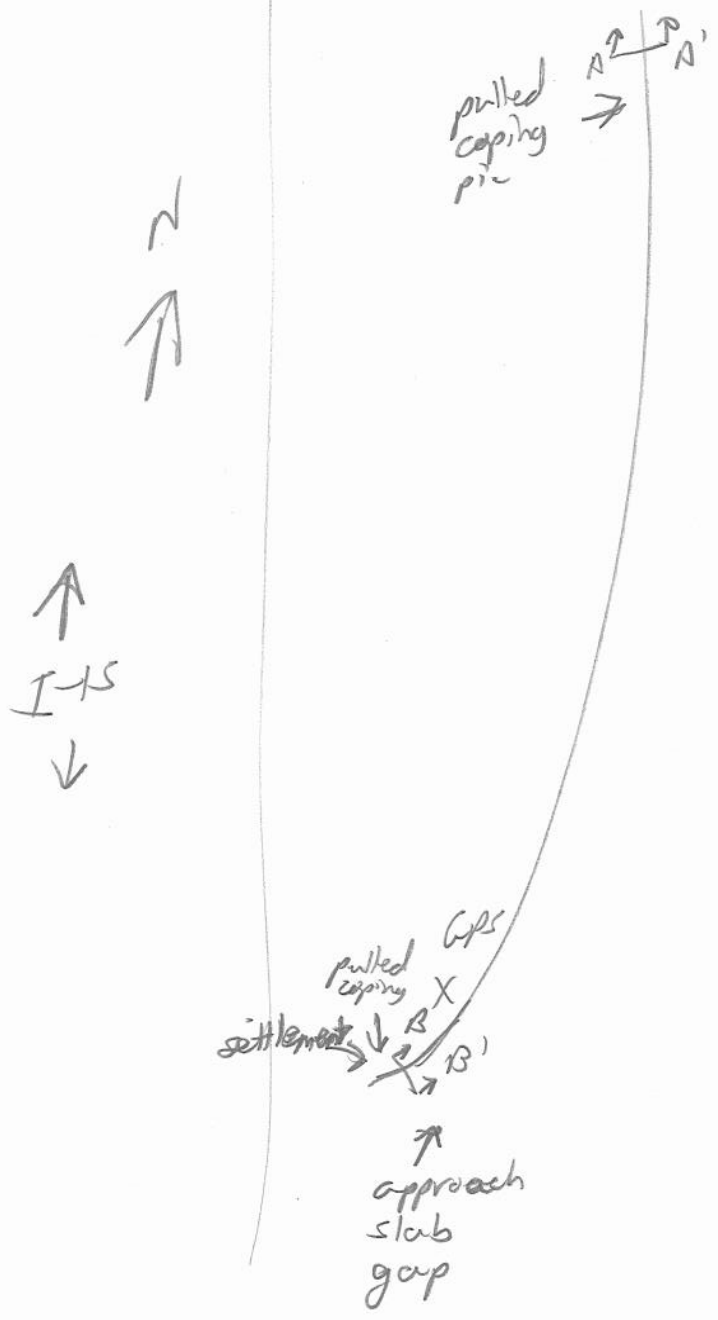
Plan View/Drainage:

Coping separating and settling
