STATE OF UTAH MSE WALL INSPECTION FORM

Compiled As Part of Research By The Utah Department of Transportation

Region	2	Identifying Road/Intersection	I-15, 600E
---------------	---	--------------------------------------	------------

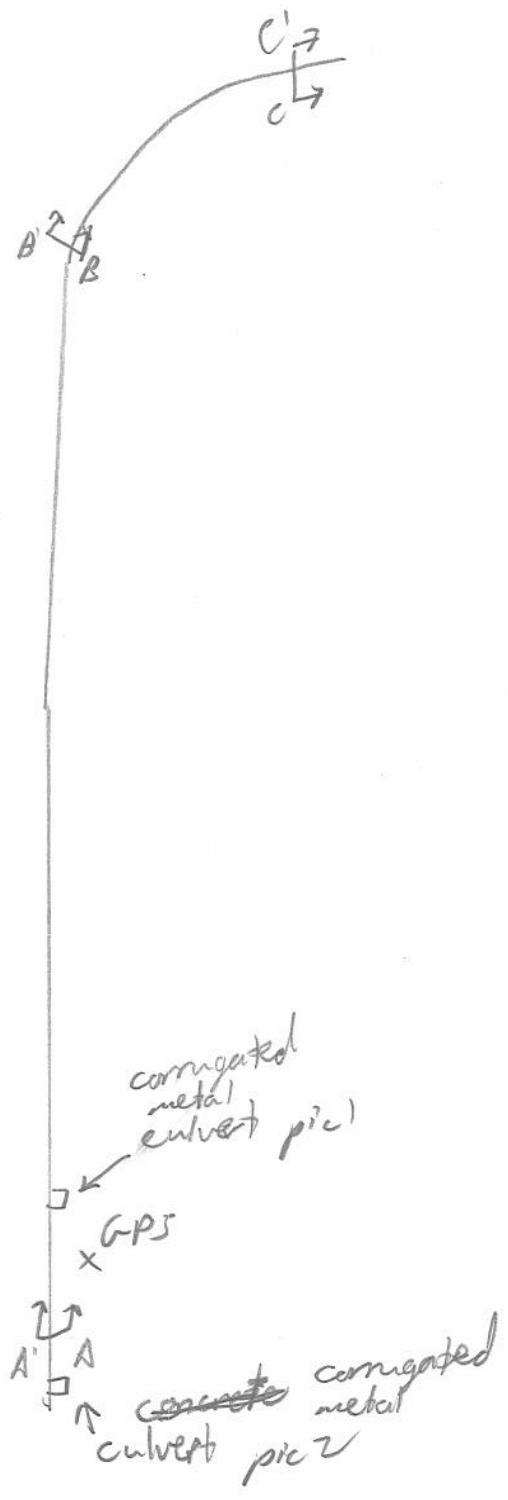
Plan View/Drainage:

house lawns grown up against the wall.
