STATE OF UTAH MSE WALL INSPECTION FORM

Inspection Date	8/21/07	Names Of Inspectors	Holly Griffin, Ryan maw
Region	2	Identifying Road/Intersection	F-15 and 10000 S

MSE Wall at Bridge	(Y) N	Bridge Number if applicable:	F-646	Wall Number	R-342
Surrounding Structures	CIP wall-center spans		Maximum Height of Wall (ft)	15'	
Distance to Each Structure	modular block south of sec. 11		One Stage, Two Stage or Block Wall	Two Stage	
State Route Number	F-15 and 10000 S		Estimated Max Length of Wall Abutment:	650'	
Approximate Mile Marker	293		Max Slope of Ground in front of wall:	3:1	
GPS Datum	WGS/84, NAD/83, or NAD/27		Max Height of wall burial line above surrounding level ground:	15'	
MSE Wall GPS Coordinates (Location of Measurement shown on plan view)	N 40° 34.168 W 111° 54.029		Please draw rough layout of panel with approximate dimensions in space provided below:		
If known, Panel or System Manufacturer	unknown

R-342 - SECTION 2 - WALL #'S 11, 12, 13, & 14
walls in good overall condition

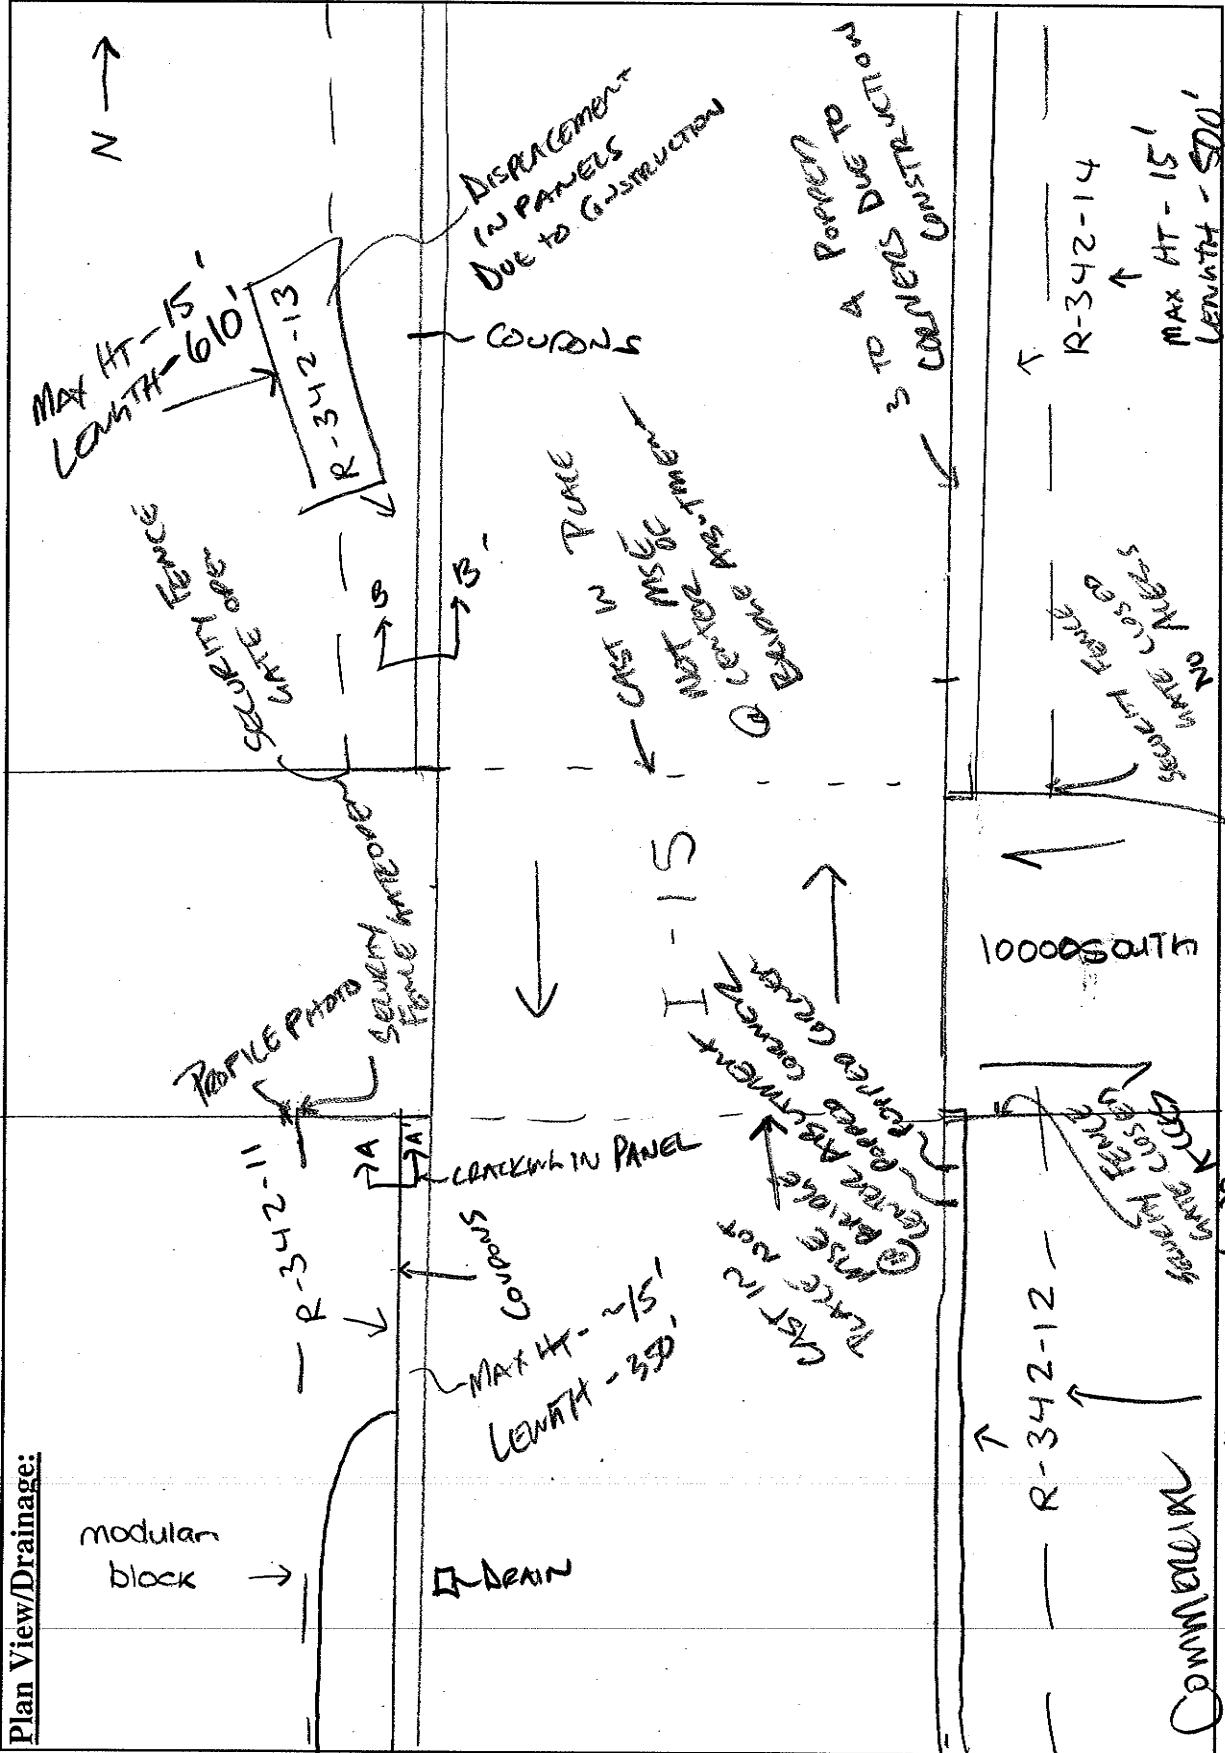
Plan View/Drainage:

modular block →

LIMITED ACCESS ON REMAINING WALLS DUE TO SECURITY FENCE -
