STATE OF UTAH MSE WALL INSPECTION FORM

Inspection Date	8/11/2009	Names Of Inspectors	RYAN MAW & HOWY
Region	2	Identifying Road/Intersection	10600 S. (SR-156) - I-15

MSE Wall at Bridge	(Y) N	Bridge Number if applicable:	F-663	Wall Number	UNKNOWN
Surrounding Structures	NONE			Maximum Height of Wall (ft)	~20'
Distance to Each Structure	-			One Stage, Two Stage or Block Wall	TWO STAGE
State Route Number	I-15			Estimated Max Length of Wall Abutment:	160'
Approximate Mile Marker	293			Max Slope of Ground in front of wall:	0'
GPS Datum	WGS/84	NAD/83, or NAD/27		Max Height of wall burial line above surrounding level ground:	0'
MSE Wall GPS Coordinates (Location of Measurement shown on plan view)	N 40° 33.497'		Please draw rough layout of panel with approximate dimensions in space provided below:		
	W 111° 53.855'				
If known, Panel or System Manufacturer	UNKNOWN

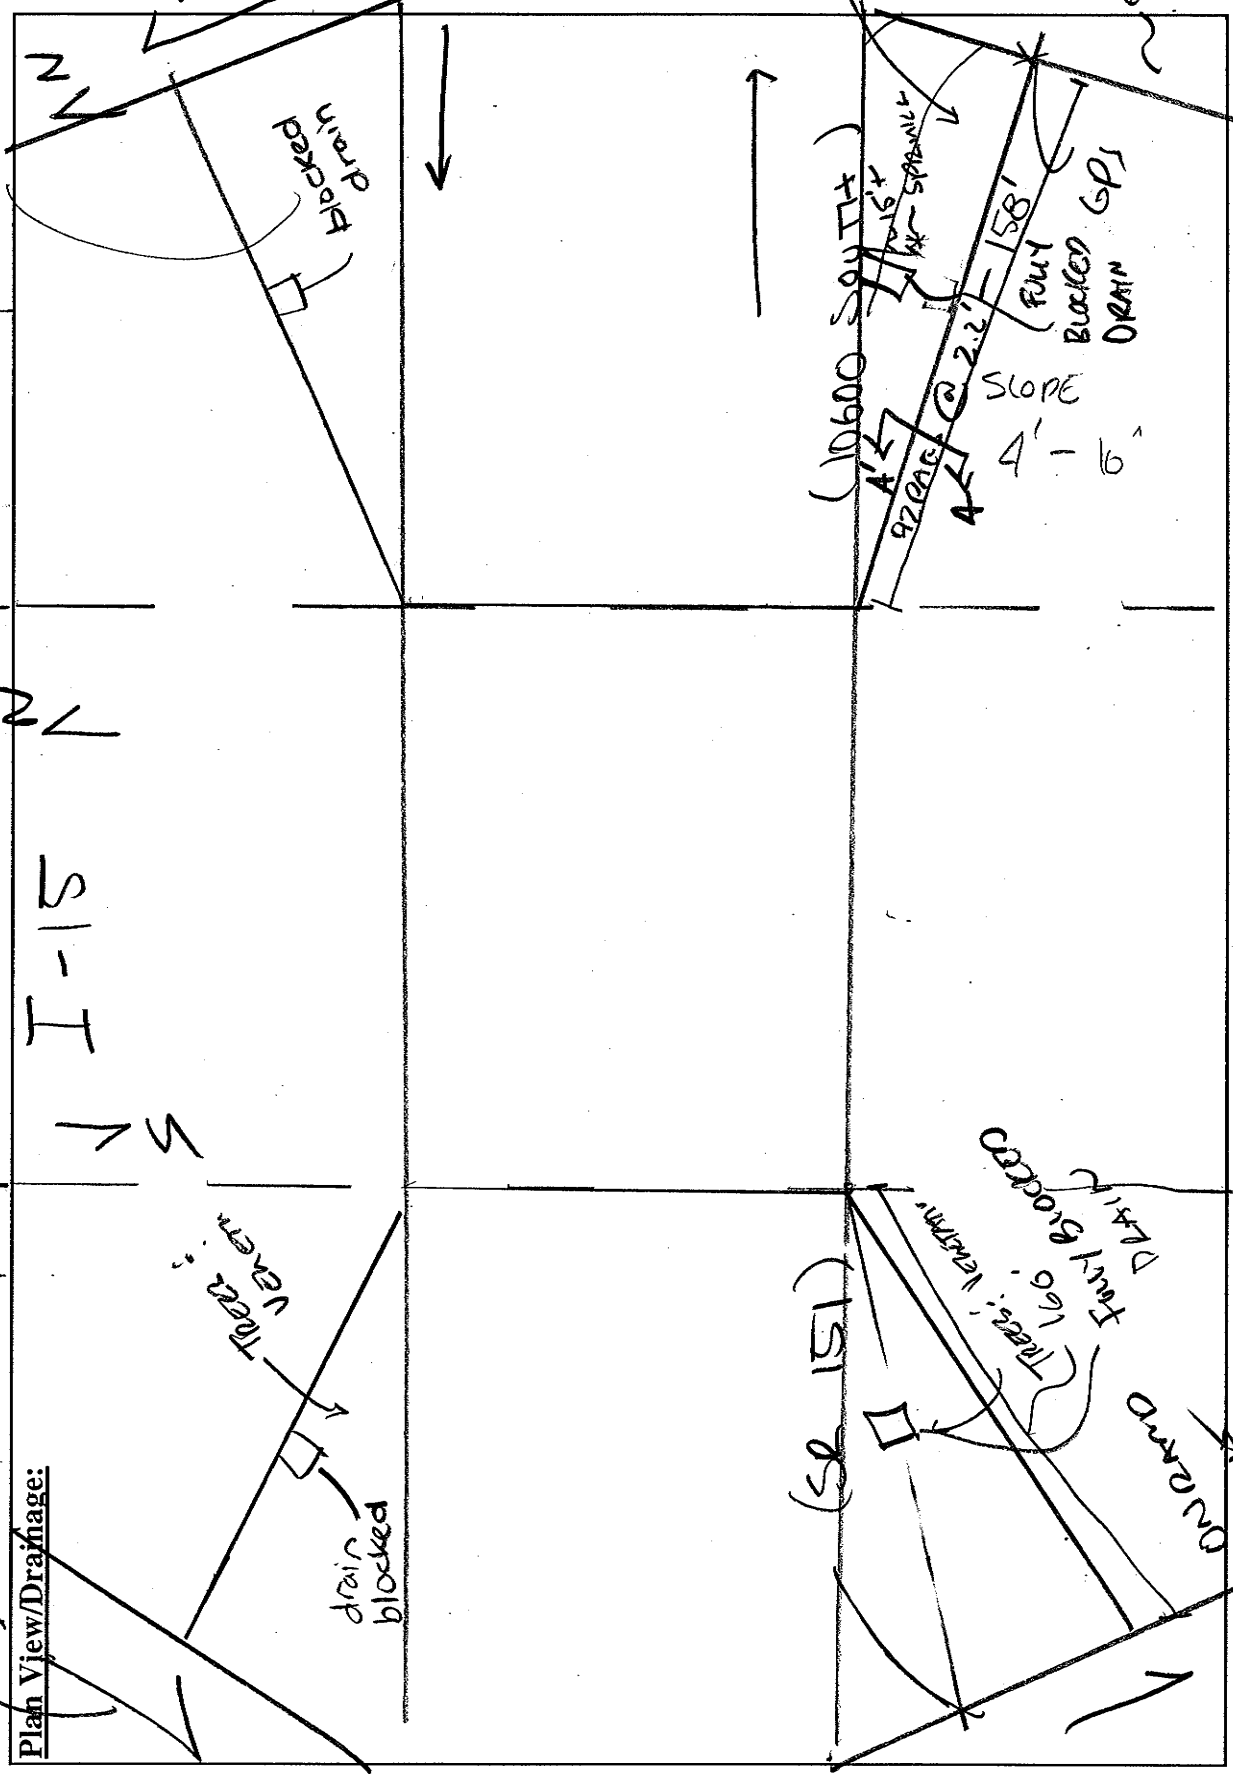
Plan View/Drainage:

* ALL FOUR DRAINS WERE BLOCKED - DRAINAGE A MAJOR CONCERN

drain
blocked

FULLY BLOCKED
DRAIN

FULLY
BLOCKED
DRAIN
GPS
