# STATE OF UTAH MSE WALL INSPECTION FORM

Compiled As Part of Research By The Utah Department of Transportation

Inspection Date	8/1/2009	Names Of Inspectors	RYAN MAN & HOLLY GRIFFIN
Region	Z	Identifying Road/Intersection	SR 48 'T-15'

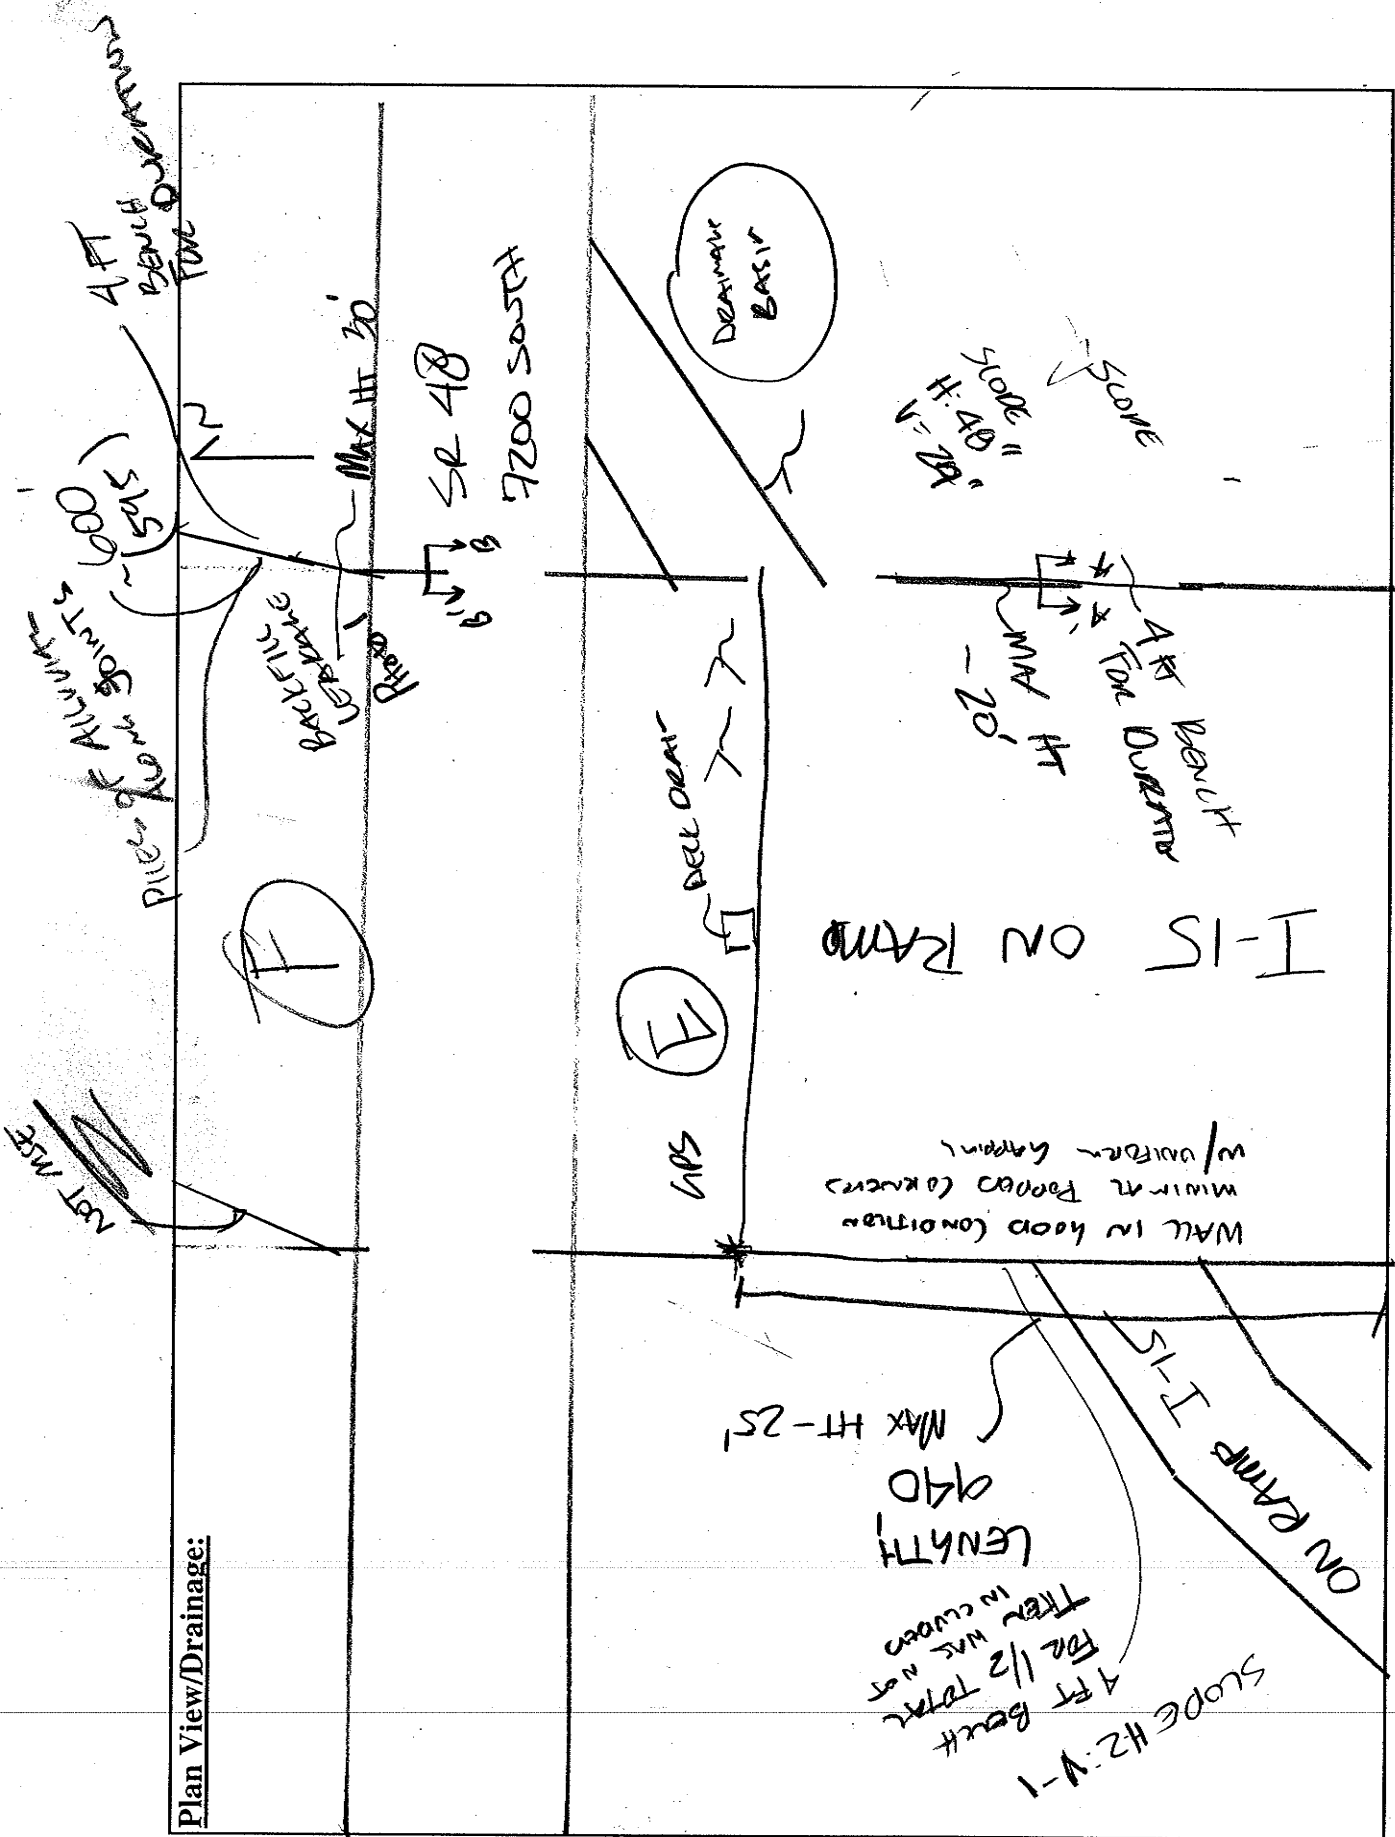
Plan View/Drainage:

wall in good condition  
minimal popped corners  
w/uniform gaps
