STATE OF UTAH MSE WALL INSPECTION FORM

Compiled As Part of Research By The Utah Department of Transportation

Inspection Date	8/1/2009	Names Of Inspectors	RYAN MAN & HOLLY GRIFFIN
Region	2	Identifying Road/Intersection	SR 48 & I-15

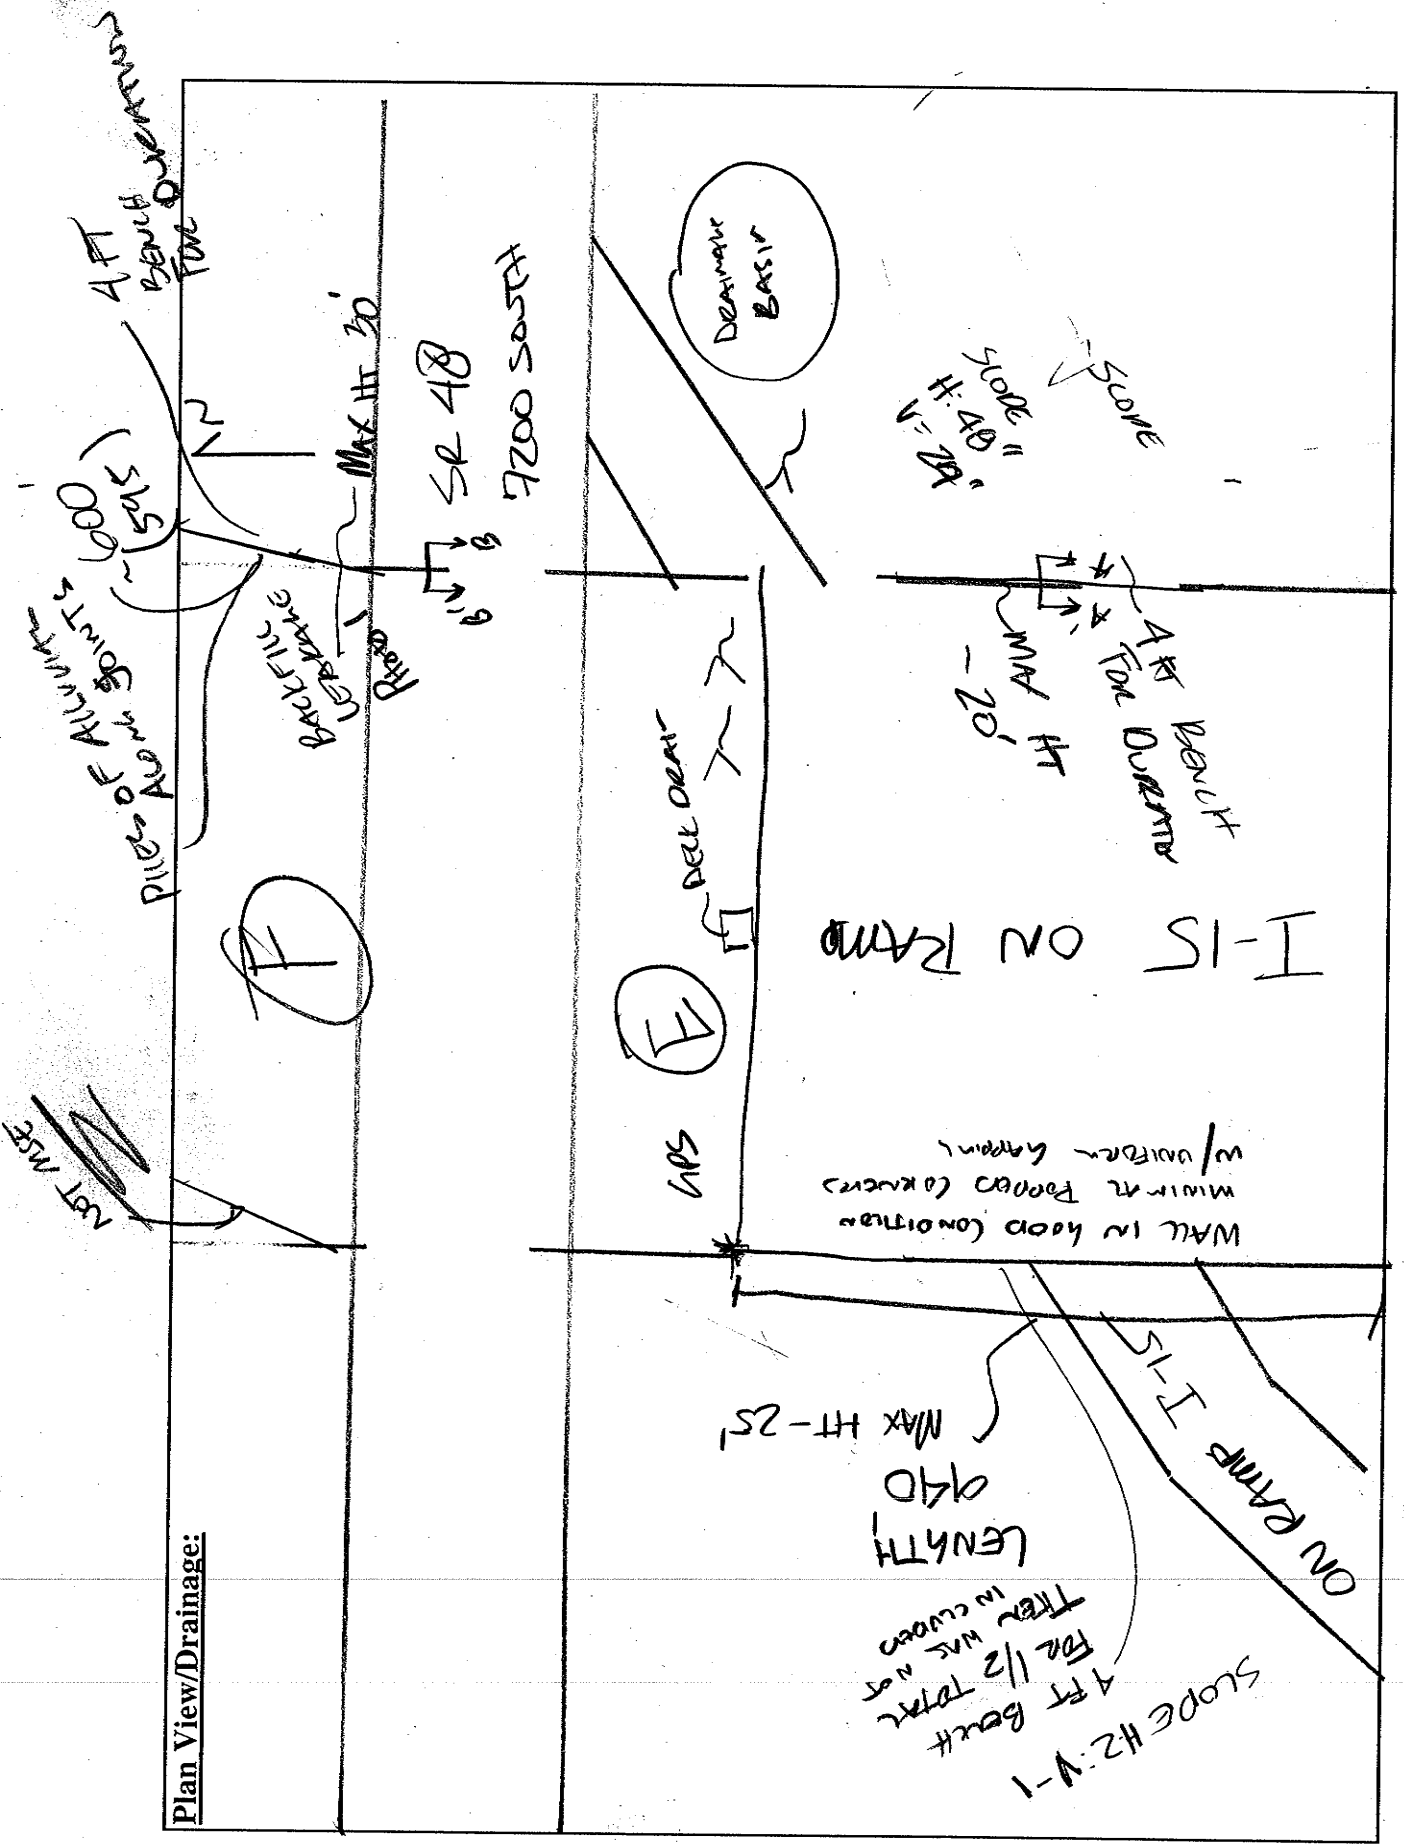
Plan View/Drainage:

wall in good condition
minimal popped corners
w/uniform gaps
