STATE OF UTAH MSE WALL INSPECTION FORM

Compiled As Part of Research By The Utah Department of Transportation

Region	2	Identifying Road/Intersection	Cedar & Adams I-80 & STATE ST.
---------------	---	--------------------------------------	-----------------------------------

MSE Wall at Bridge	<input checked="" type="radio"/> Y <input type="radio"/> N	Bridge Number if applicable:		Wall Number	R-348-7	
Surrounding Structures	—			Maximum Height of Wall (ft)	22 22'	
Distance to Each Structure	—			One Stage, Two Stage or Block Wall		
State Route Number				Estimated Max Length of Wall Abutment:	63 x 8' = 504'	
Approximate Mile Marker				Max Slope of Ground in front of wall:	flat	
GPS Datum	WGS/84, NAD/83, or NAD/27				Max Height of wall burial line above surrounding level ground:	—
MSE Wall GPS Coordinates (Location of Measurement shown on plan view)	40°43' 04.17"N 111°53'24.9"W		Please draw rough layout of panel with approximate dimensions in space provided below:			
If known, Panel or System Manufacturer	<div style="display: flex; align-items: center; justify-content: center;"> <div style="border: 1px solid black; width: 100px; height: 100px; margin-right: 20px;"></div> <div style="t

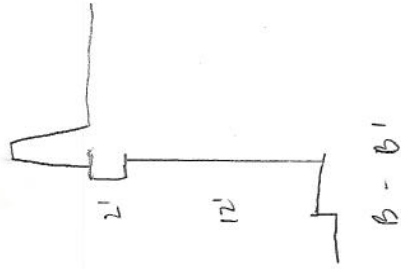
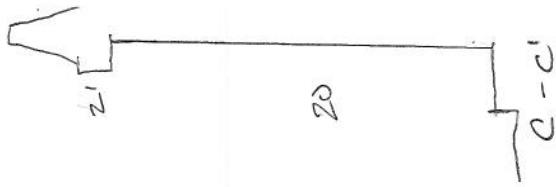
Cross Sections:

< 2 FT
vines & trees at base
Can't access top
