STATE OF UTAH MSE WALL INSPECTION FORM

Compiled As Part of Research By The Utah Department of Transportation

Region	2	Identifying Road/Intersection	H-201 & 900 W
---------------	---	--------------------------------------	---------------

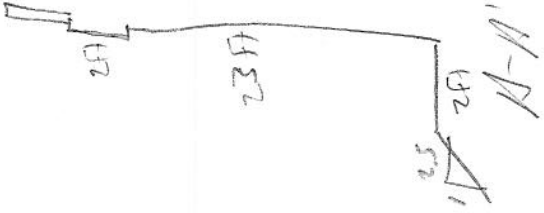
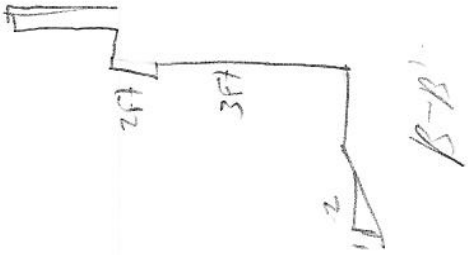
Cross Sections:

compression fractures in coping along joints and uneven settlement near toe. (east end)
