STATE OF UTAH MSE WALL INSPECTION FORM

Compiled As Part of Research By The Utah Department of Transportation

Region	2	Identifying Road/Intersection	900 W HARVIS
--------	---	-------------------------------	--------------

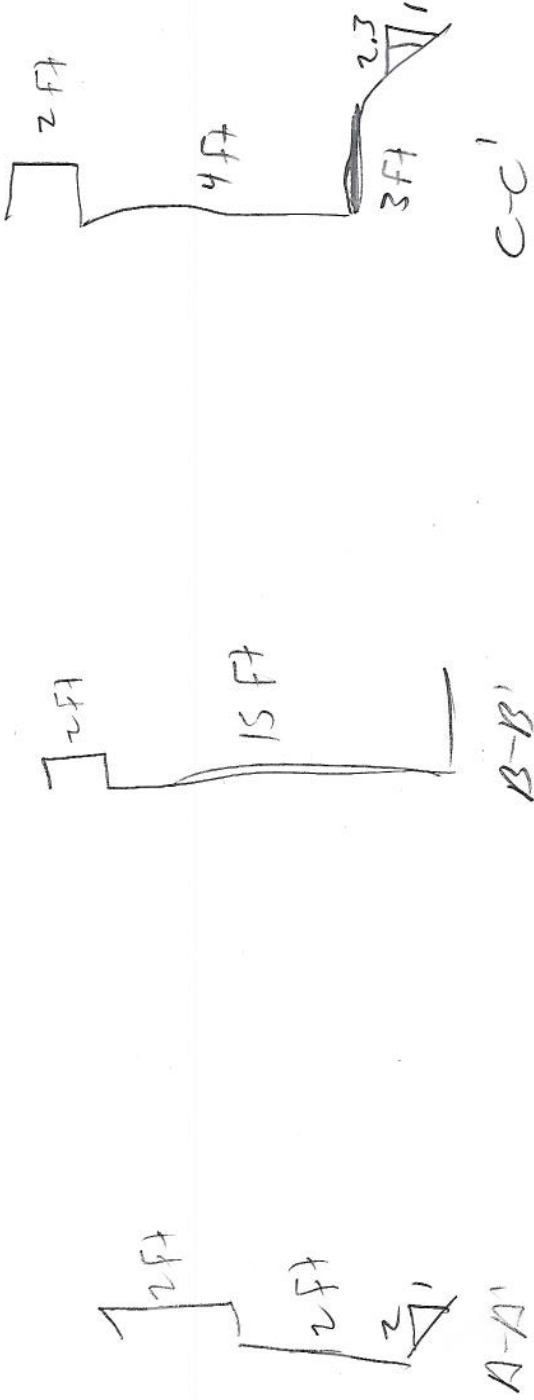
Cross Sections:

- erosion at end of wall
