STATE OF UTAH MSE WALL INSPECTION FORM

Inspection Date	7/1/07	Names Of Inspectors	Ryan maw & Holly Griffin
Region	2	Identifying Road/Intersection	WGS (SR-209) & I-15

MSE Wall at Bridge	(Y) N	Bridge Number if applicable:	unknown	Wall Number	R-349
Surrounding Structures	N/A			Maximum Height of Wall (ft)	23.5 ft
Distance to Each Structure	N/A			One Stage, Two Stage or Block Wall	two stage
State Route Number	209			Estimated Max Length of Wall Abutment:	85 ft
Approximate Mile Marker				Max Slope of Ground in front of wall:	1:30:1H
GPS Datum	(WGS/84), NAD/83, or NAD/27			Max Height of wall burial line above surrounding level ground:	10
MSE Wall GPS Coordinates (Location of Measurement shown on plan view)	N 40° 43.465		Please draw rough layout of panel with approximate dimensions in space provided below:

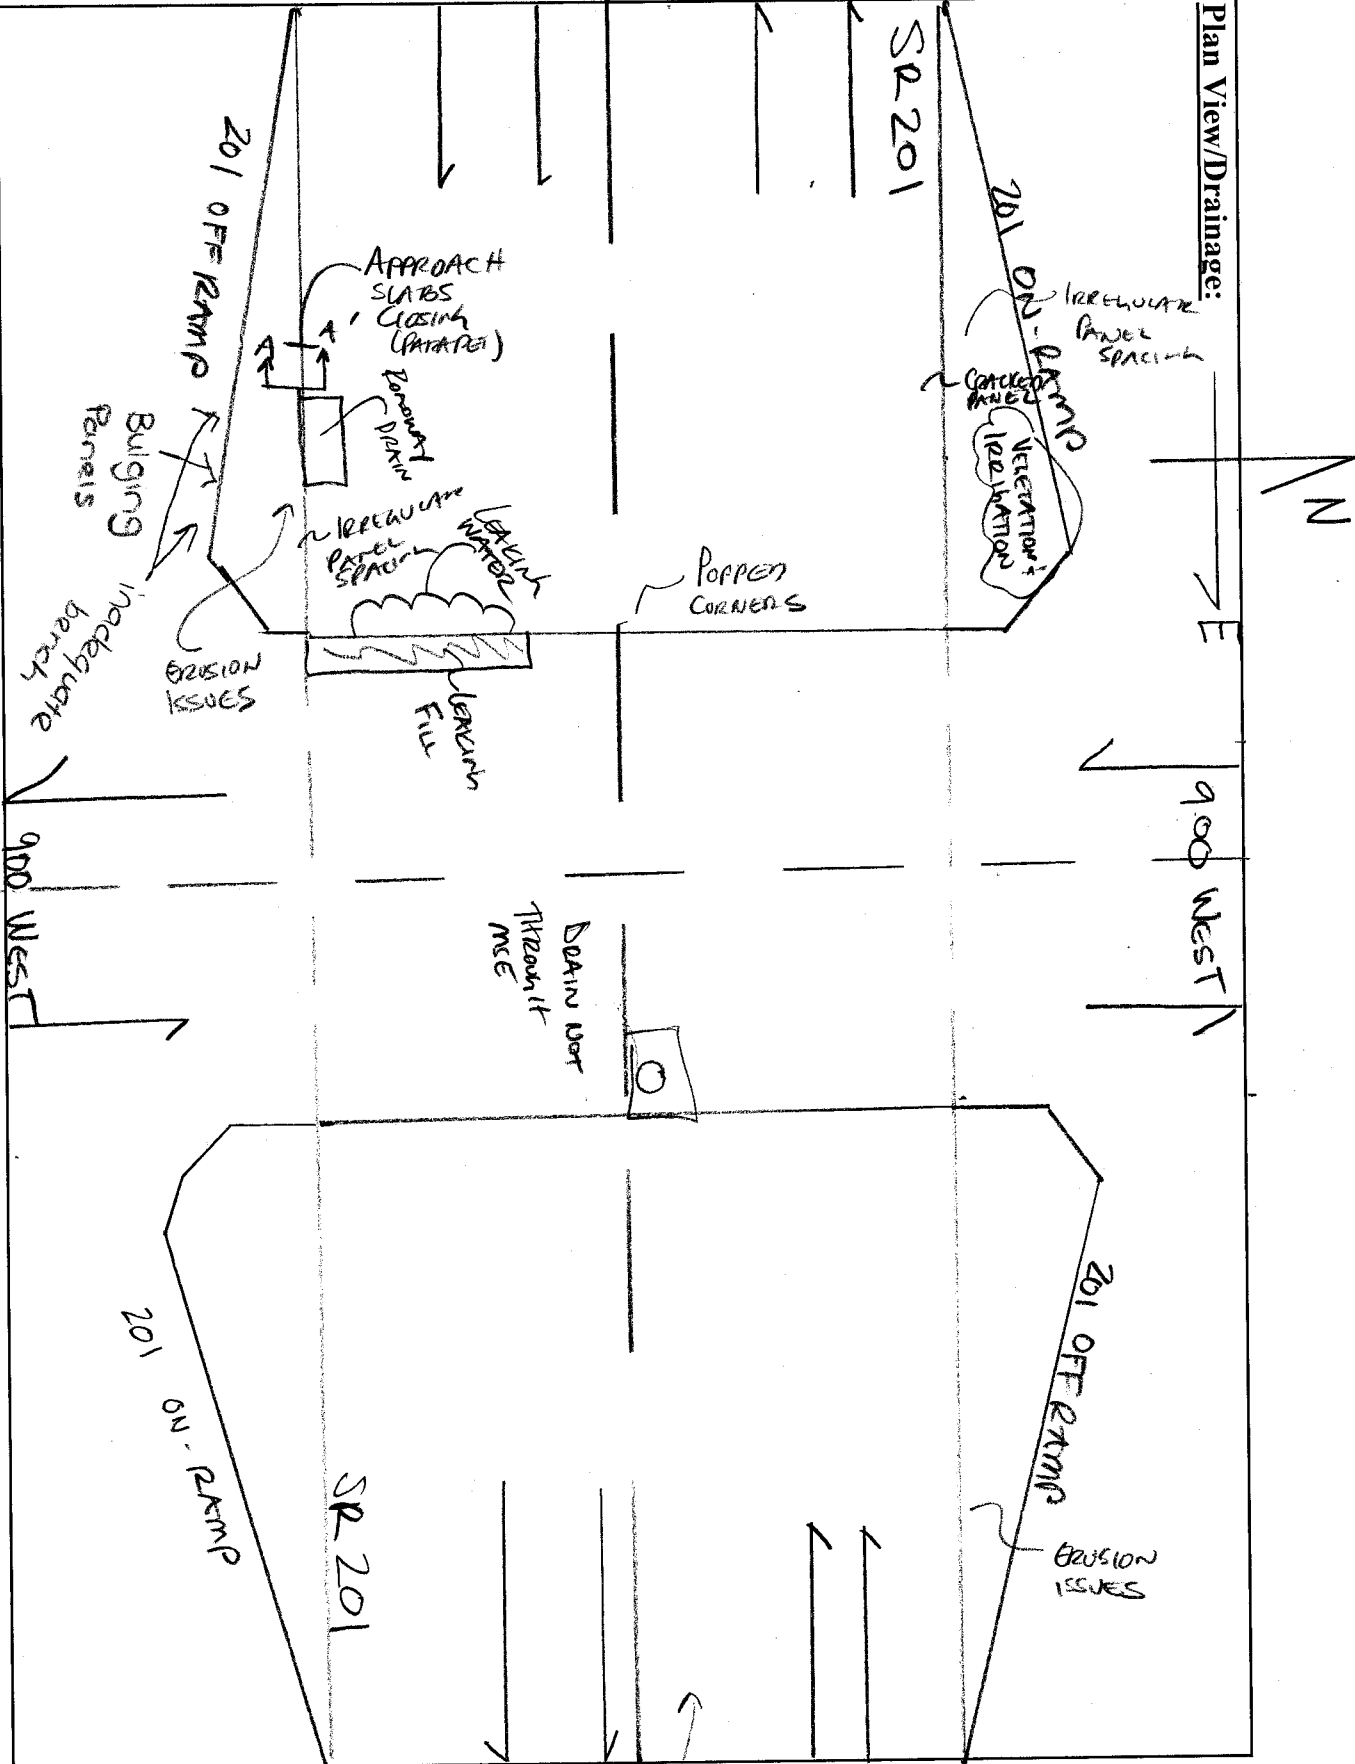
Joint Inspection w/ BYU
 Severe drainage issues
 wall actually losing fill (history of problems)
 joint spacing irregularities
 erosion along base of wall
 bowing / offset in panels

THIS SIDE IN BETTER
 CONDITION W/LIMITED
 PROBLEMS BY COMPARISON TO WEST WALL
