STATE OF UTAH MSE WALL INSPECTION FORM

Compiled As Part of Research By The Utah Department of Transportation

| Region | 2 | Identifying Road/Intersection | Colm & Adam 17005 & I-15 |

| MSE Wall at Bridge | Y <input checked="" type="radio"/> N | Bridge Number if applicable: | F-635 | Wall Number | R-350-11 |

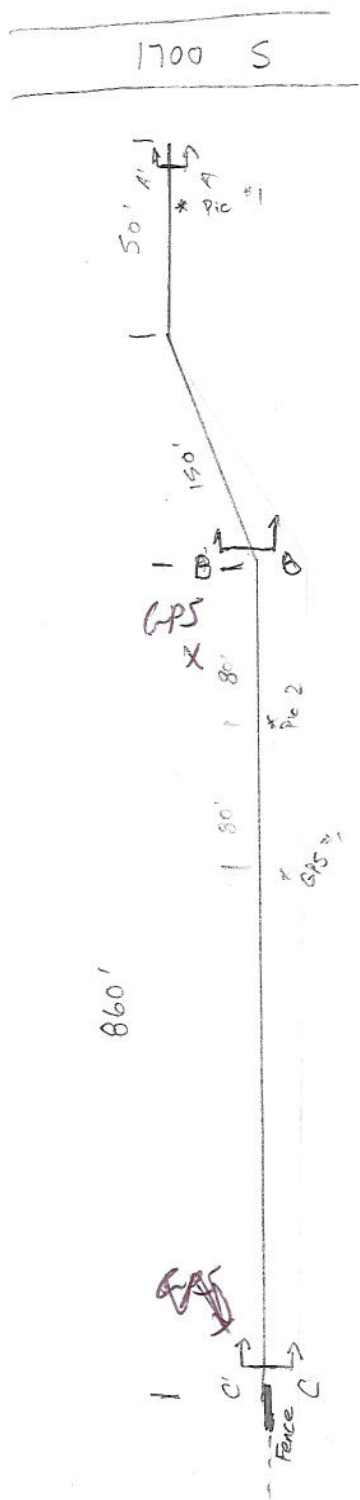
Plan View/Drainage:

- small amount of backfill coming out of wall
- top of wall inaccessible

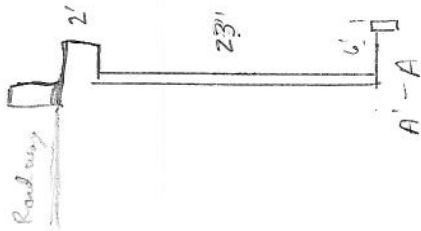
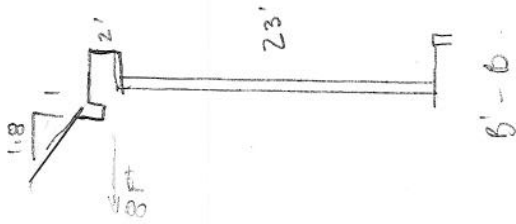
Cross Sections:

All Plumb
