STATE OF UTAH MSE WALL INSPECTION FORM

Compiled As Part of Research By The Utah Department of Transportation

Region	2	Identifying Road/Intersection	I-15, 900S, SLC
---------------	---	--------------------------------------	-----------------

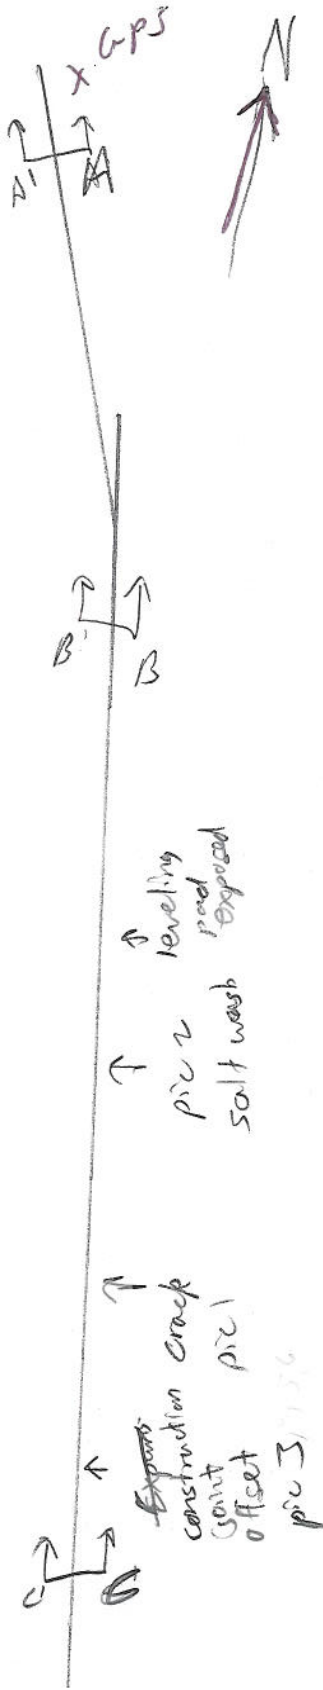
Plan View/Drainage:

vertical offset
