STATE OF UTAH MSE WALL INSPECTION FORM

Compiled As Part of Research By The Utah Department of Transportation

Region	2	Identifying Road/Intersection	Colin F Adams 200 S, 1000 W (WOST II)
---------------	---	--------------------------------------	--

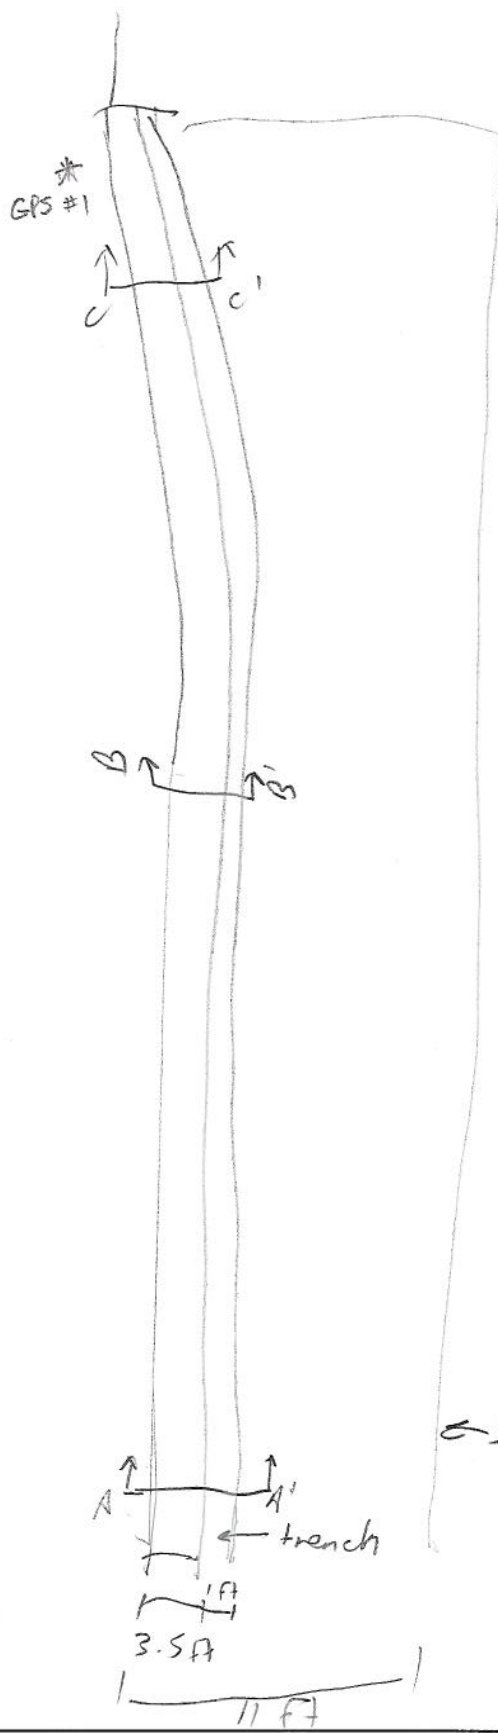
Plan View/Drainage:

← sound wall

← trench
