# STATE OF UTAH MSE WALL INSPECTION FORM

Compiled As Part of Research By The Utah Department of Transportation

<b>Region</b>	2	<b>Identifying Road/Intersection</b>	Colin & Adam 200 S 100 W (East)
---------------	---	--------------------------------------	------------------------------------

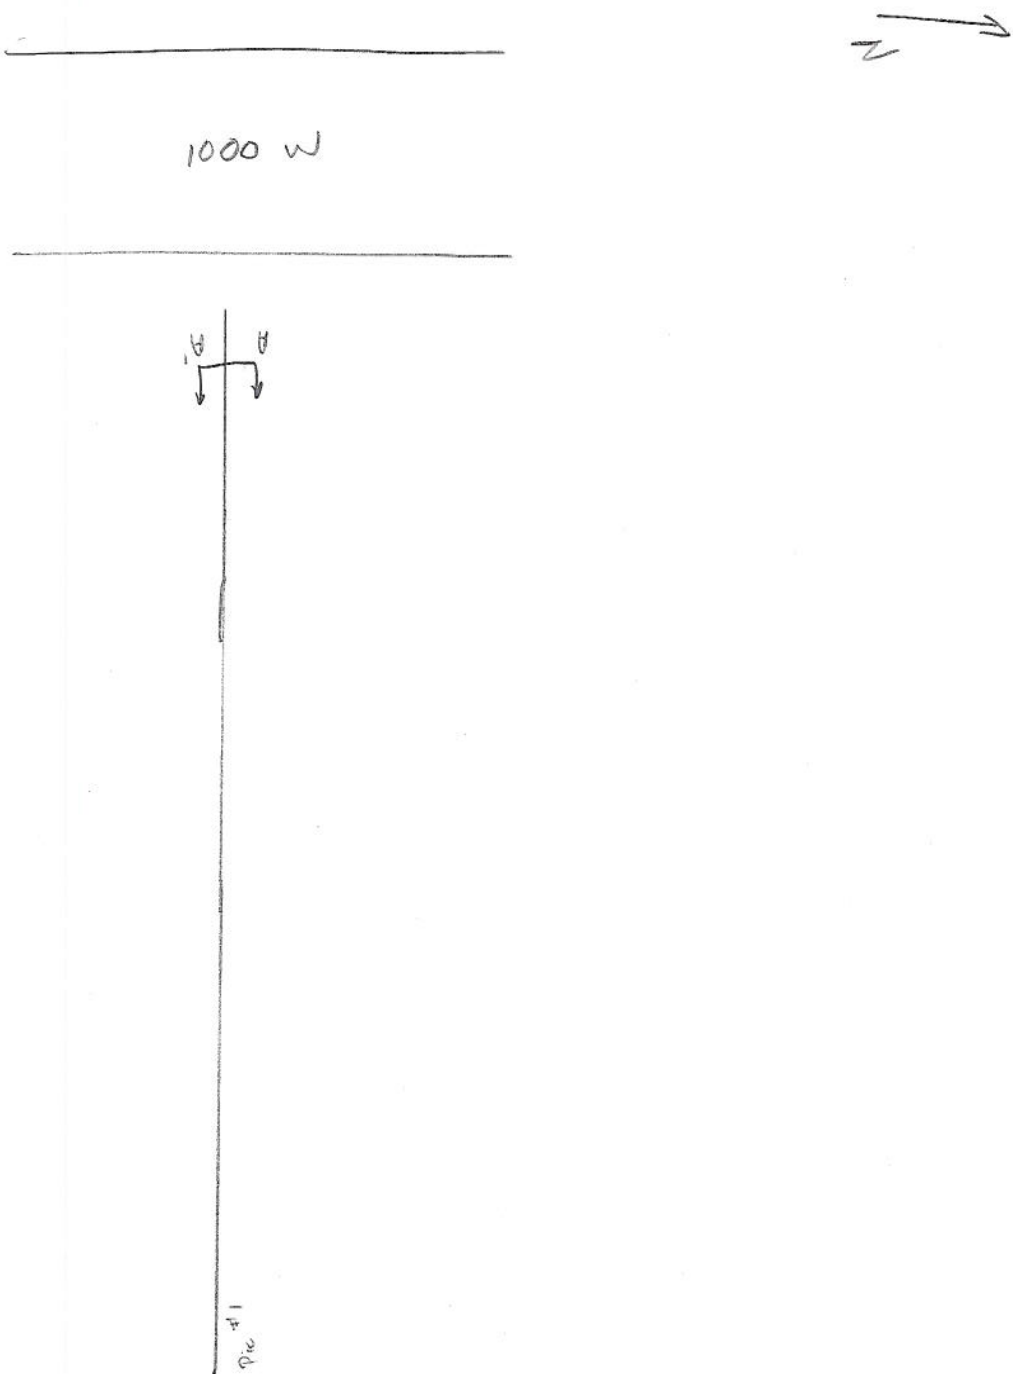
Plan View/Drainage:

- irrigation pipes located at base
