STATE OF UTAH MSE WALL INSPECTION FORM

Compiled As Part of Research By The Utah Department of Transportation

Region	2	Identifying Road/Intersection	700 W, #00-300 N
---------------	---	--------------------------------------	------------------

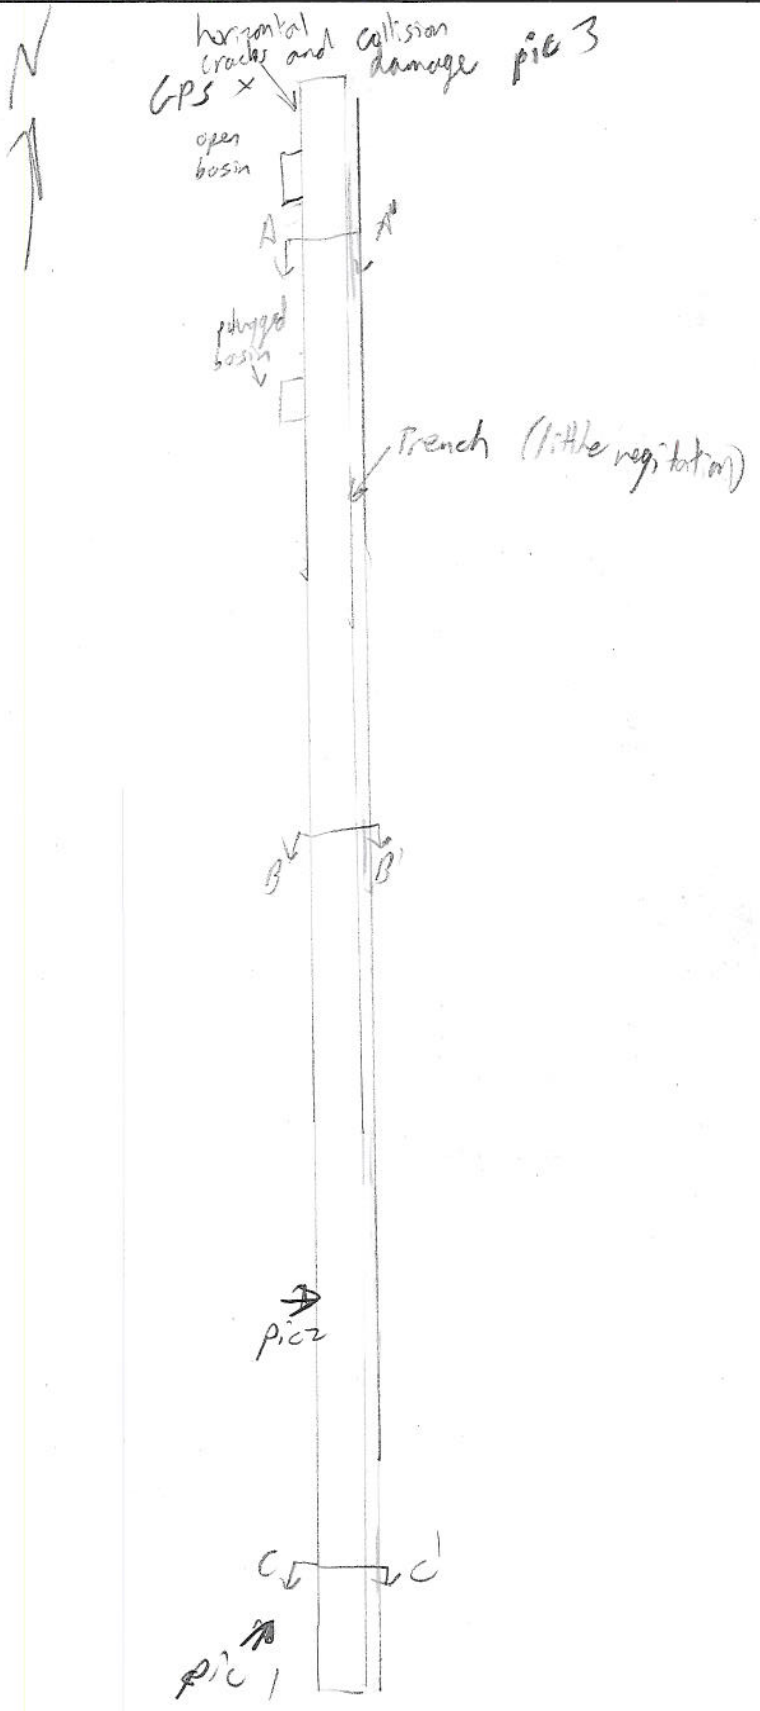
Plan View/Drainage:

collision at north end
