# STATE OF UTAH MSE WALL INSPECTION FORM

Inspection Date	7-20-07	Names Of Inspectors	Colin & Adam
Region	2	Identifying Road/Intersection	R15 near 300 N - 500 N. SLC

MSE Wall at Bridge	(Y) N	Bridge Number if applicable: 351 (30)	Wall Number	R-351-30
Surrounding Structures	800m Houses 300N to 400 N		Maximum Height of Wall (ft)	22 ft
Distance to Each Structure	50 ft ±		One or Two Stage Wall	Two Stage
State Route Number			Estimated Max Length of Wall Abutment:	3 blocks (680')
Approximate Mile Marker			Max Slope of Ground in front of wall:	0
GPS Datum	WGS/84, NAD/83, or NAD/27		Max Height of wall burial line above surrounding level ground:	0
MSE Wall GPS Coordinates (Location of Measurement shown on plan view)	40° 46.676' N, 111° 54.959' W		Please draw rough layout of panel with approximate dimensions in space provided below:	
If known, Panel or System Manufacturer	VSL

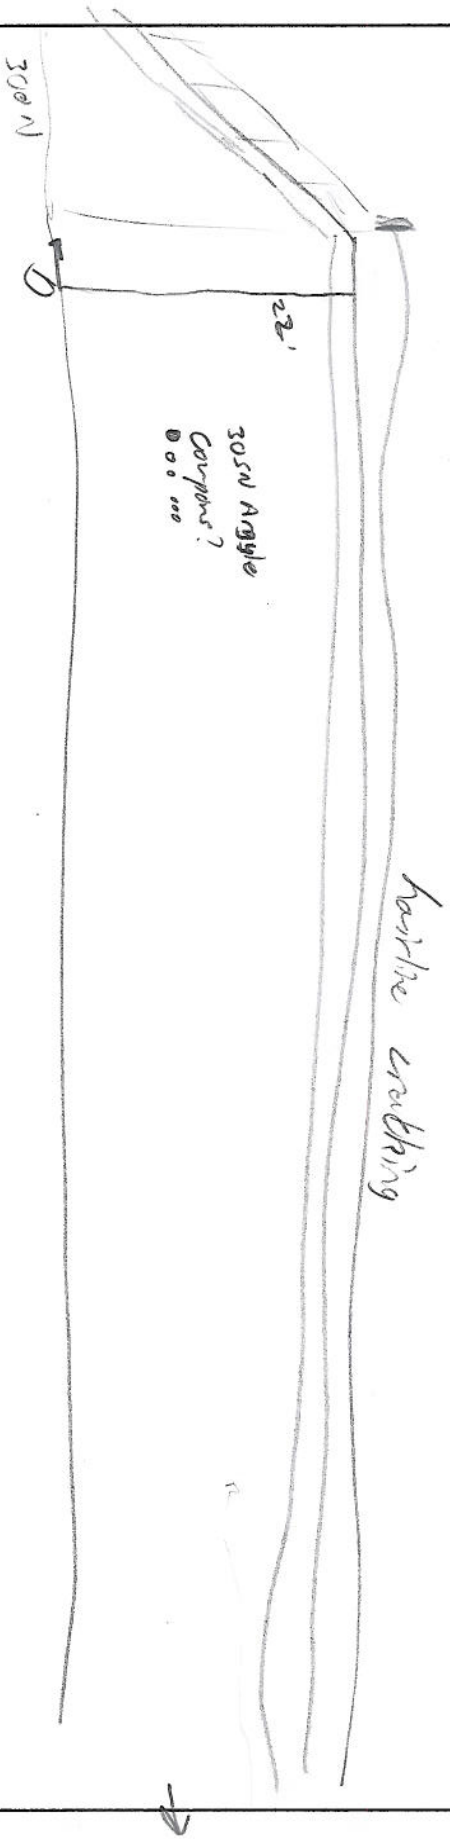
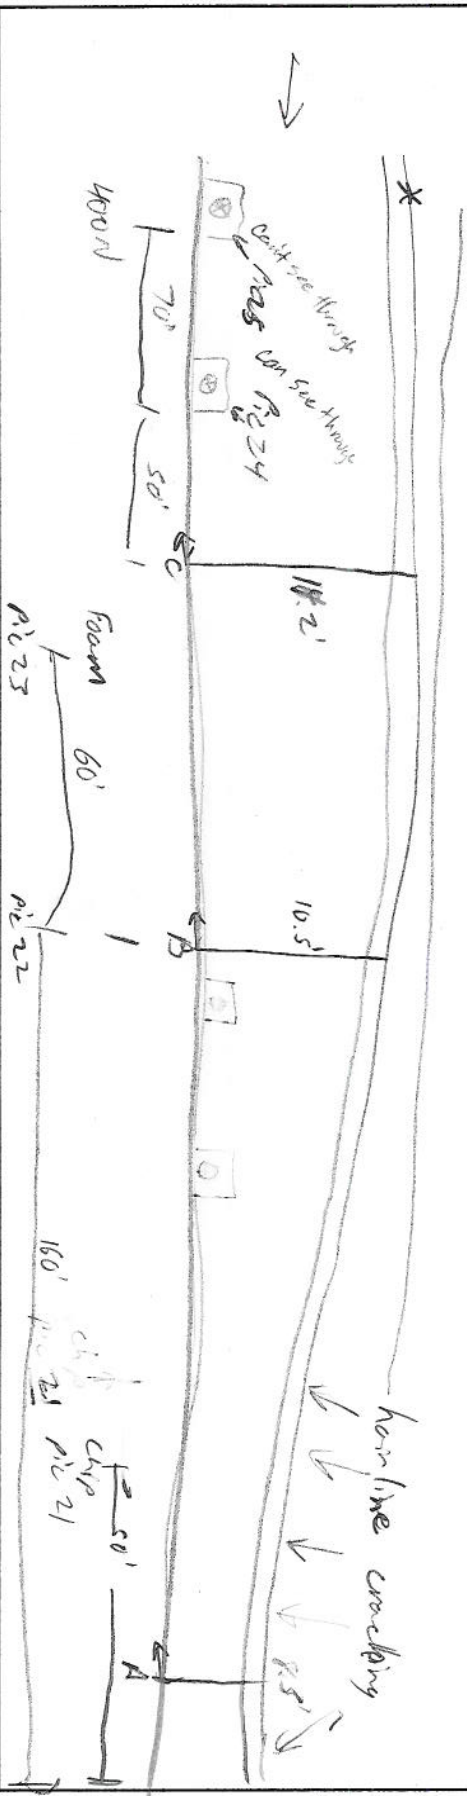
**Plan View/Drainage:**

- vegetation at top and bottom
  - exposed leveling pad (100 ft)
  - ~~culverts~~ through wall (partially clogged), not
  - difficult to observe barred entry, offsets (if any) are minimal
  - residents built right up to wall
- only bottom invert visible ↓
