STATE OF UTAH MSE WALL INSPECTION FORM

Region	2	Identifying Road/Intersection	400 S over rail road tracks (West side)
---------------	---	--------------------------------------	---

MSE Wall at Bridge	(Y) N	Bridge Number if applicable:	C-204	Wall Number	351-34
Surrounding Structures				Maximum Height of Wall (ft)	23.5'
Distance to Each Structure				One Stage, Two Stage or Block Wall	2 stage
State Route Number				Estimated Max Length of Wall Abutment:	250+ = 465 FT
Approximate Mile Marker				Max Slope of Ground in front of wall:	0
GPS Datum	WGS/84, NAD/83, or NAD/27			Max Height of wall burial line above surrounding level ground:	Unknown
MSE Wall GPS Coordinates (Location of Measurement shown on plan view)	40° 45' 39.25" N, 111° 54' 38.56" W				
If known, Panel or System Manufacturer

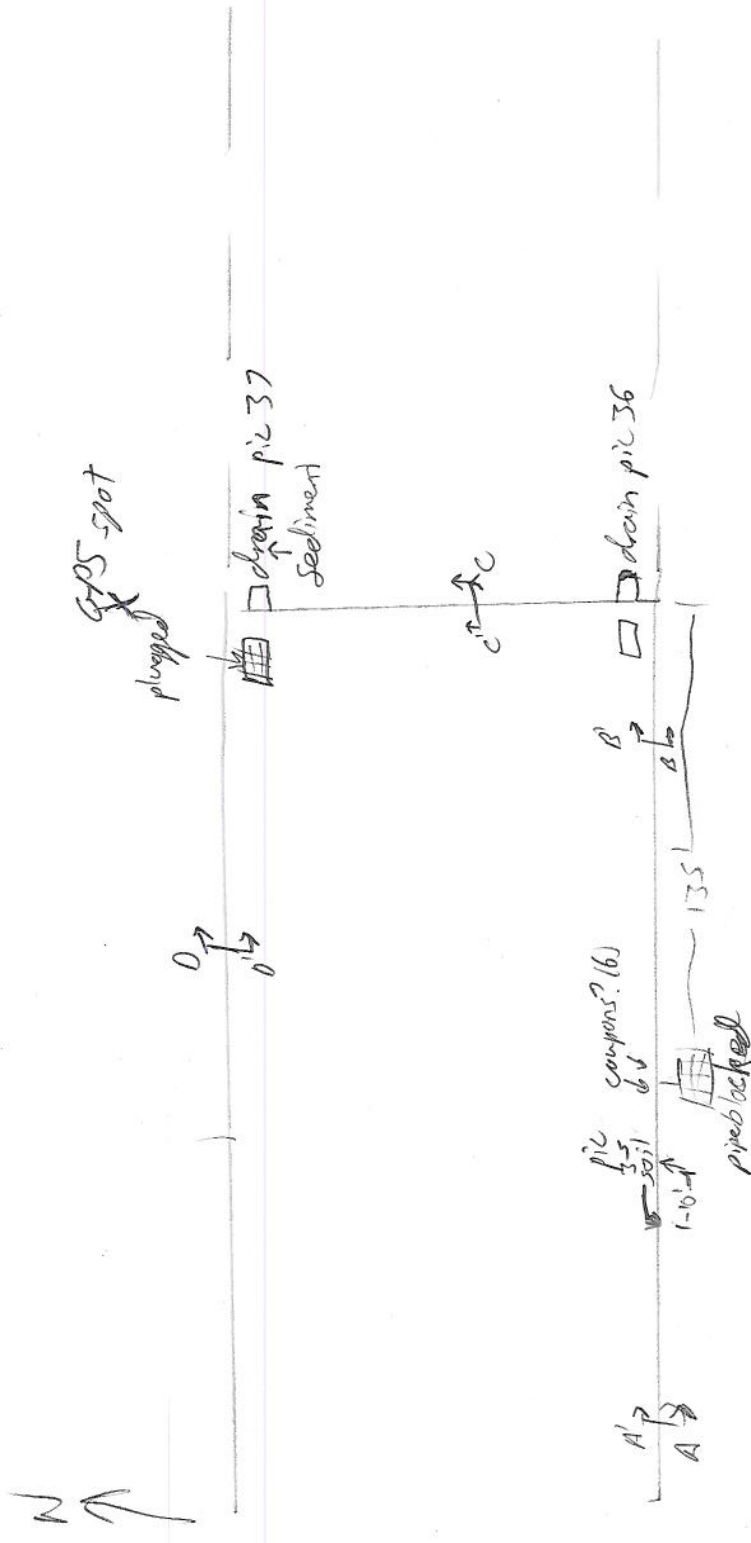
Plan View/Drainage:

most all fractures are result of construction and not post-construction
 drains are mostly plugged
 some backfill coming from joints on south side
 minor offsets in panel faces
