NISE WALL DRAINAGE

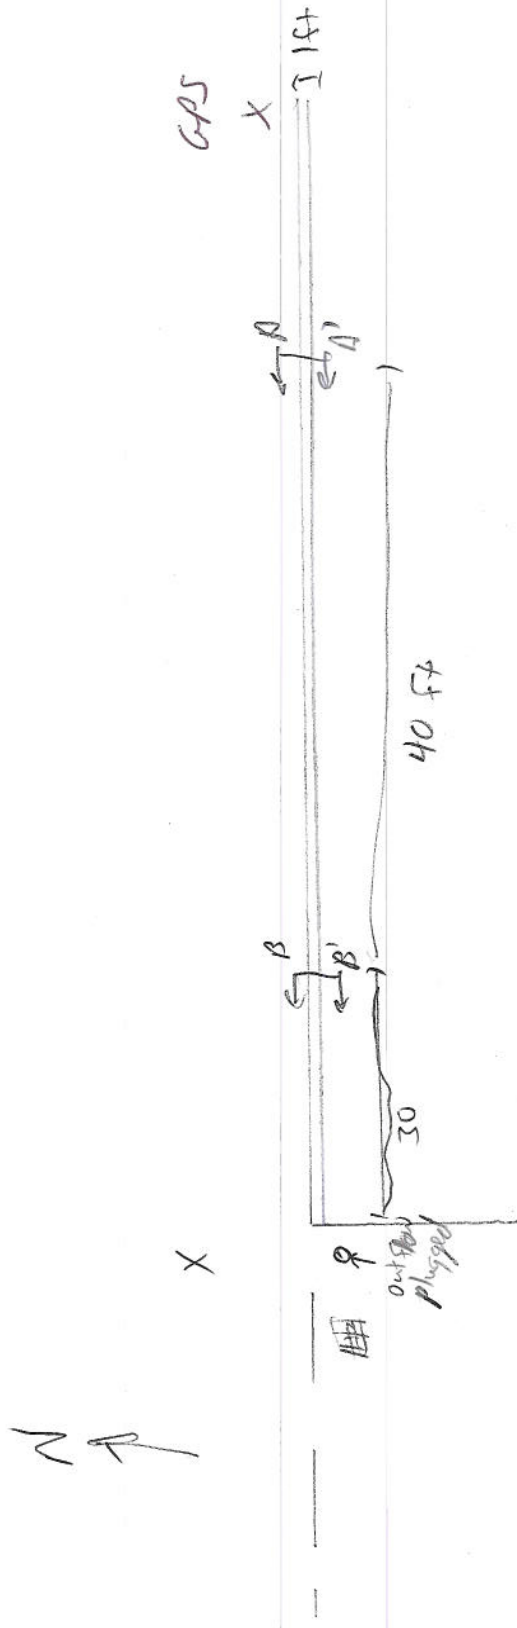
Plan View/Drainage:

*drain is pipe at bottom blocked*
