# STATE OF UTAH MSE WALL INSPECTION FORM

Compiled As Part of Research By The Utah Department of Transportation

<b>Region</b>	<b>Identifying Road/Intersection</b>	I-15 onramp from 500 S, 520
---------------	--------------------------------------	-----------------------------

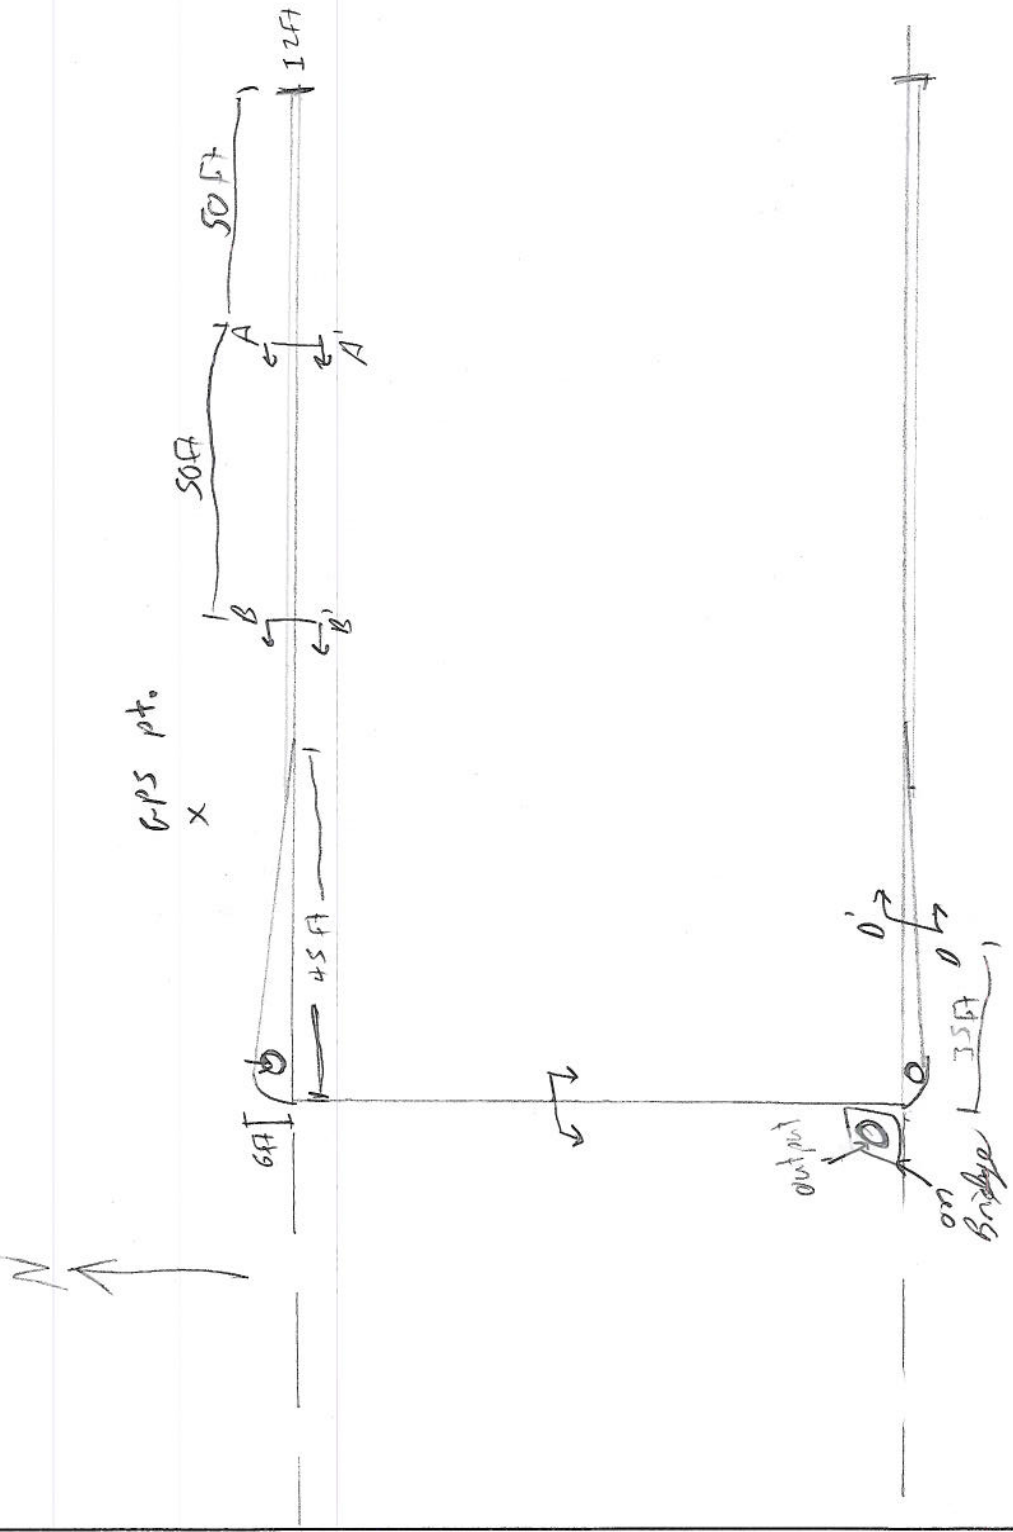
Plan View/Drainage:

lots of vegetation on north face.
