STATE OF UTAH MSE WALL INSPECTION FORM

Compiled As Part of Research By The Utah Department of Transportation

Region	Identifying Road/Intersection	I-15 near passing 9005
---------------	--------------------------------------	------------------------

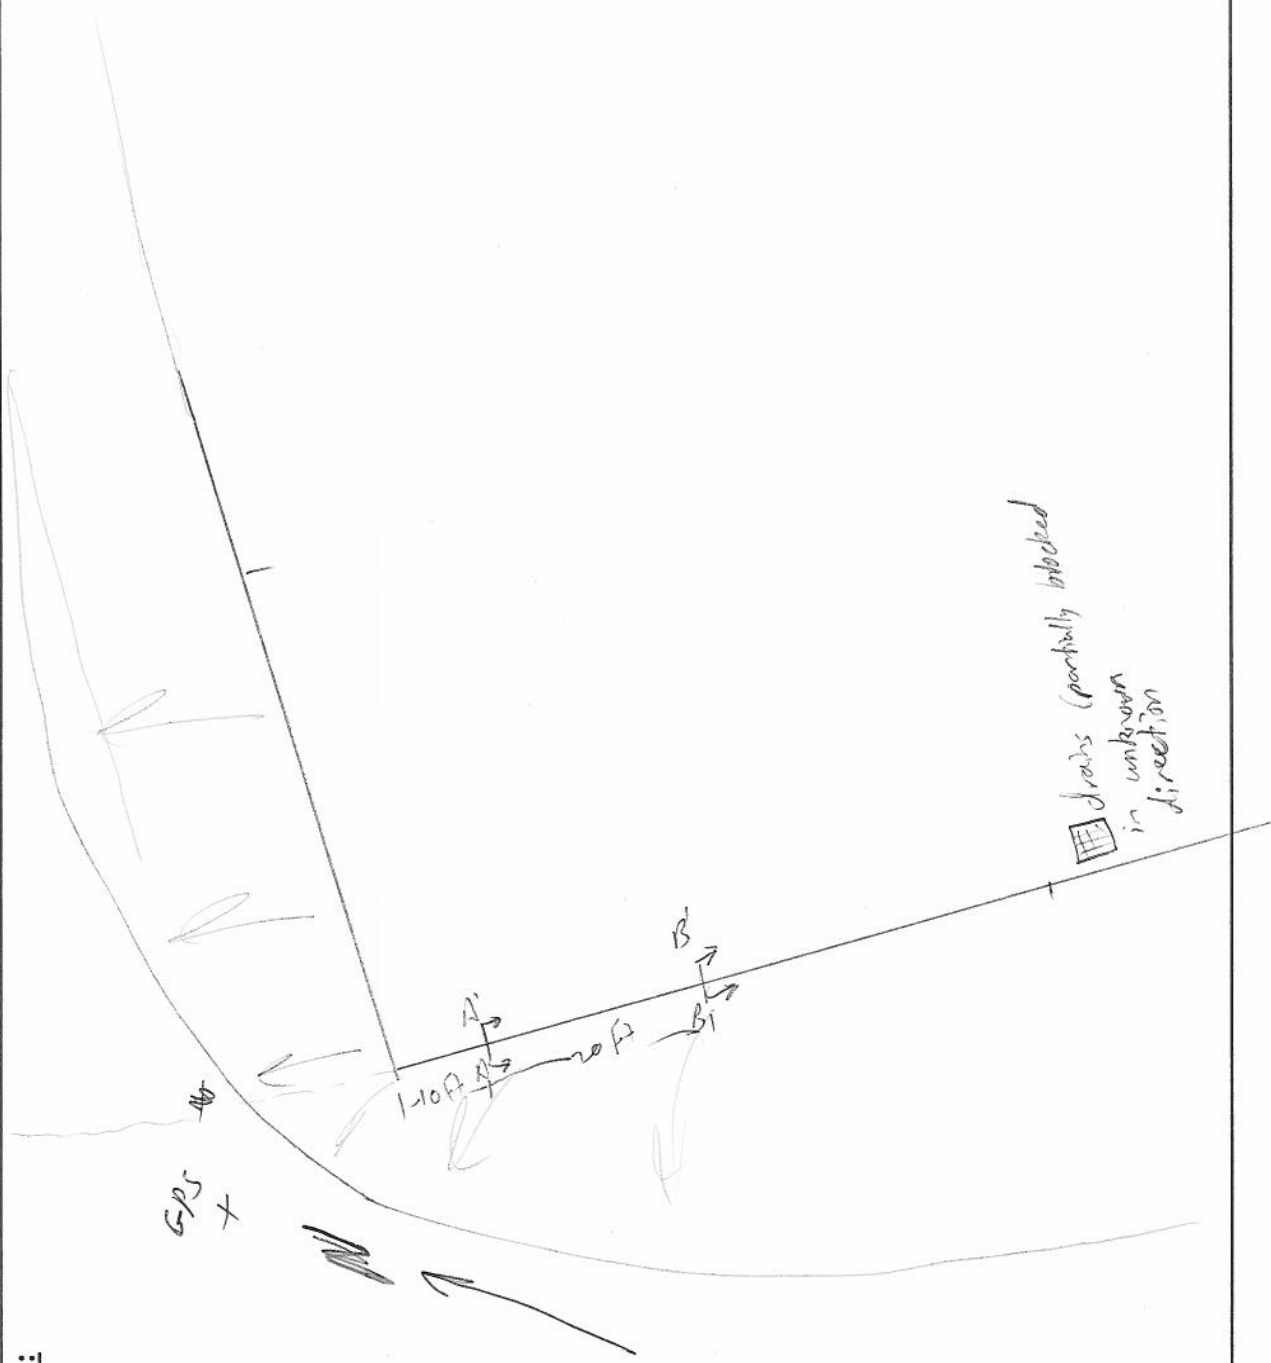
Plan View/Drainage:

concrete slope reinforcement to avoid railway
