# STATE OF UTAH MSE WALL INSPECTION FORM

Compiled As Part of Research By The Utah Department of Transportation

<b>Region</b>	12	<b>Identifying Road/Intersection</b>	I-15, 8005, SLC
---------------	----	--------------------------------------	-----------------

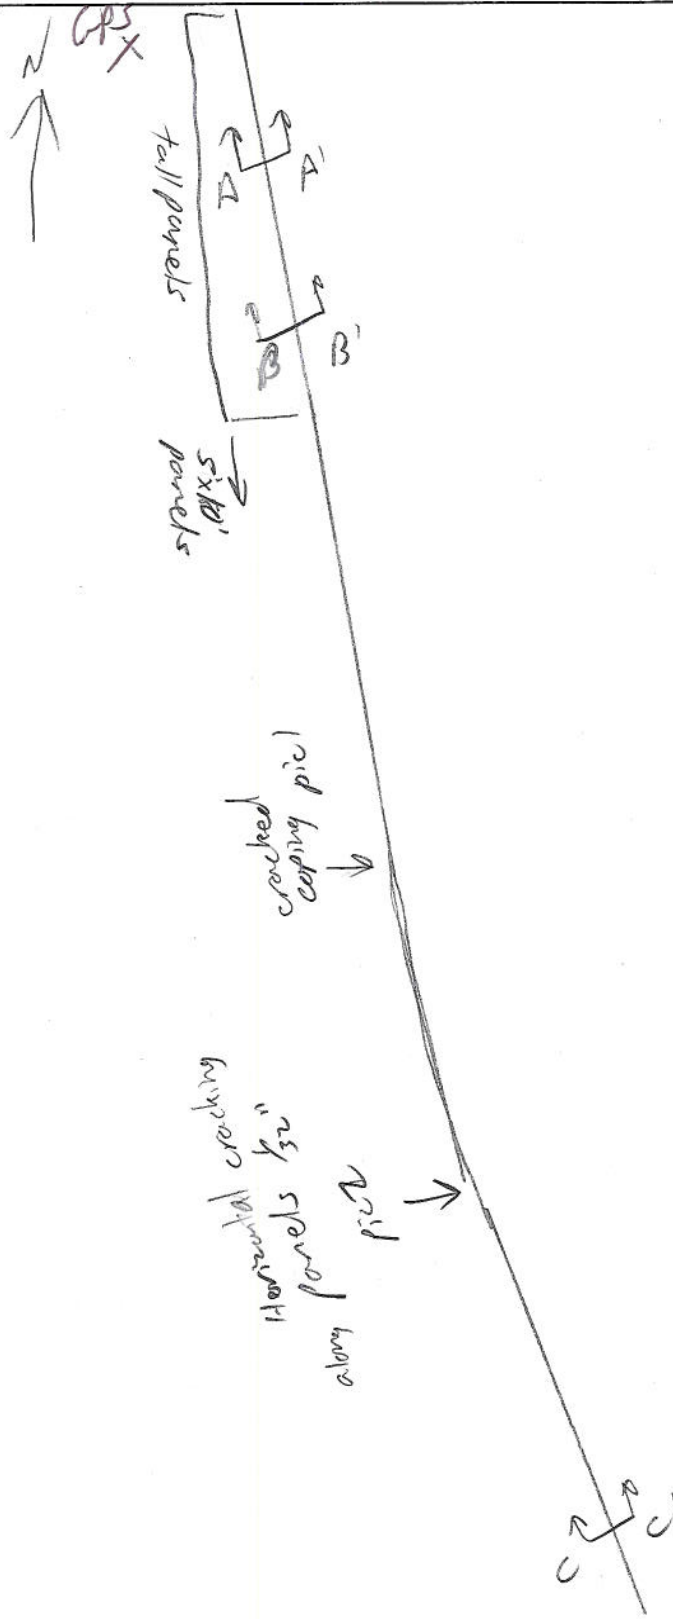
Plan View/Drainage:

**Summary of Key Observations:**  
*several horizontal cracks (1 extends to more panels)*
