# STATE OF UTAH MSE WALL INSPECTION FORM

Compiled As Part of Research By The Utah Department of Transportation

<b>Region</b>	~	<b>Identifying Road/Intersection</b>
		200 S, I-15, SLC

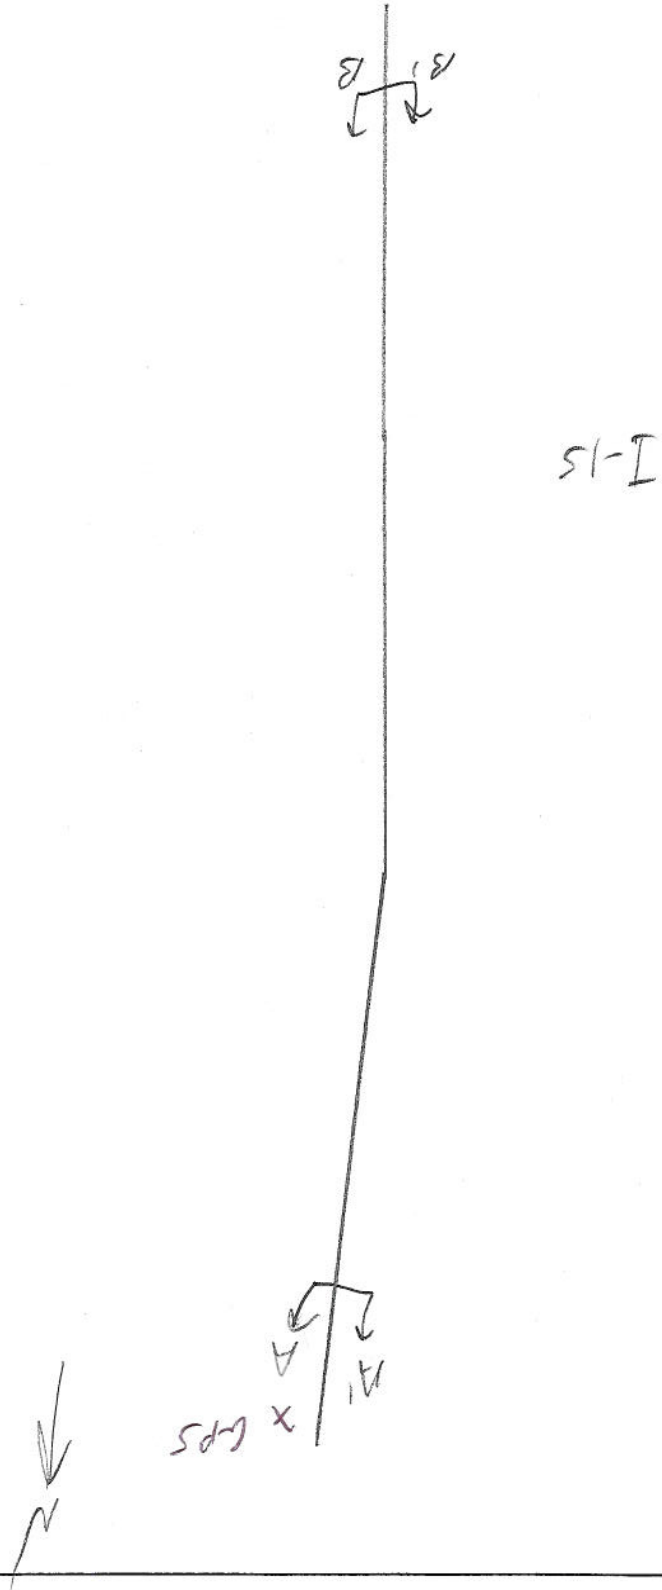
Plan View/Drainage:

panels tipping, skinny shelf
