STATE OF UTAH MSE WALL INSPECTION FORM

Compiled As Part of Research By The Utah Department of Transportation

Region	2	Identifying Road/Intersection	E-15, N. Temp - S. Temp
---------------	---	--------------------------------------	-------------------------

MSE Wall at Bridge	(Y) N	Bridge Number if applicable:		Wall Number	R-351-46
Surrounding Structures				Maximum Height of Wall (ft)	11 ft
Distance to Each Structure				One Stage, Two Stage or Block Wall	2-stage
State Route Number				Estimated Max Length of Wall Abutment:	580 ft
Approximate Mile Marker				Max Slope of Ground in front of wall:	0
GPS Datum	WGS/84, NAD/83, or NAD/27			Max Height of wall burial line above surrounding level ground:	16 ft
MSE Wall GPS Coordinates (Location of Measurement shown on plan view)	40° 46' 16.62" N 111° 54' 40.72" W			Please draw rough layout of panel with approximate dimensions in space provided below:	
If known, Panel or System Manufacturer	<div style="border: 1px solid black; width: 200px; height: 100px; margin: 0 auto; position: relative;"> 10' 5' </div>

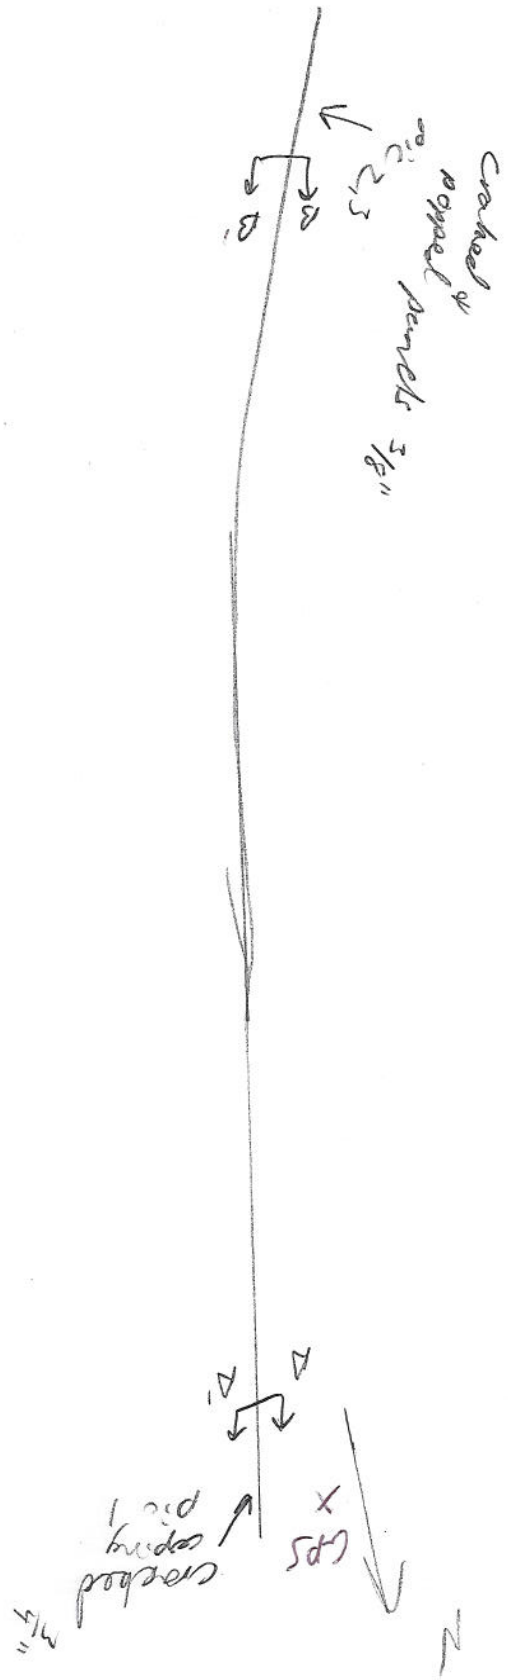
Plan View/Drainage:

- Cracking of coping (Pic 1)
- 5 different panels with cracked corners
- 1 panel with crack along entire height
