# STATE OF UTAH MSE WALL INSPECTION FORM

Compiled As Part of Research By The Utah Department of Transportation

<b>Region</b>	Z	<b>Identifying Road/Intersection</b>	I-80 WEST OFF RAMP OVER 4005
---------------	---	--------------------------------------	------------------------------

39-90 wall

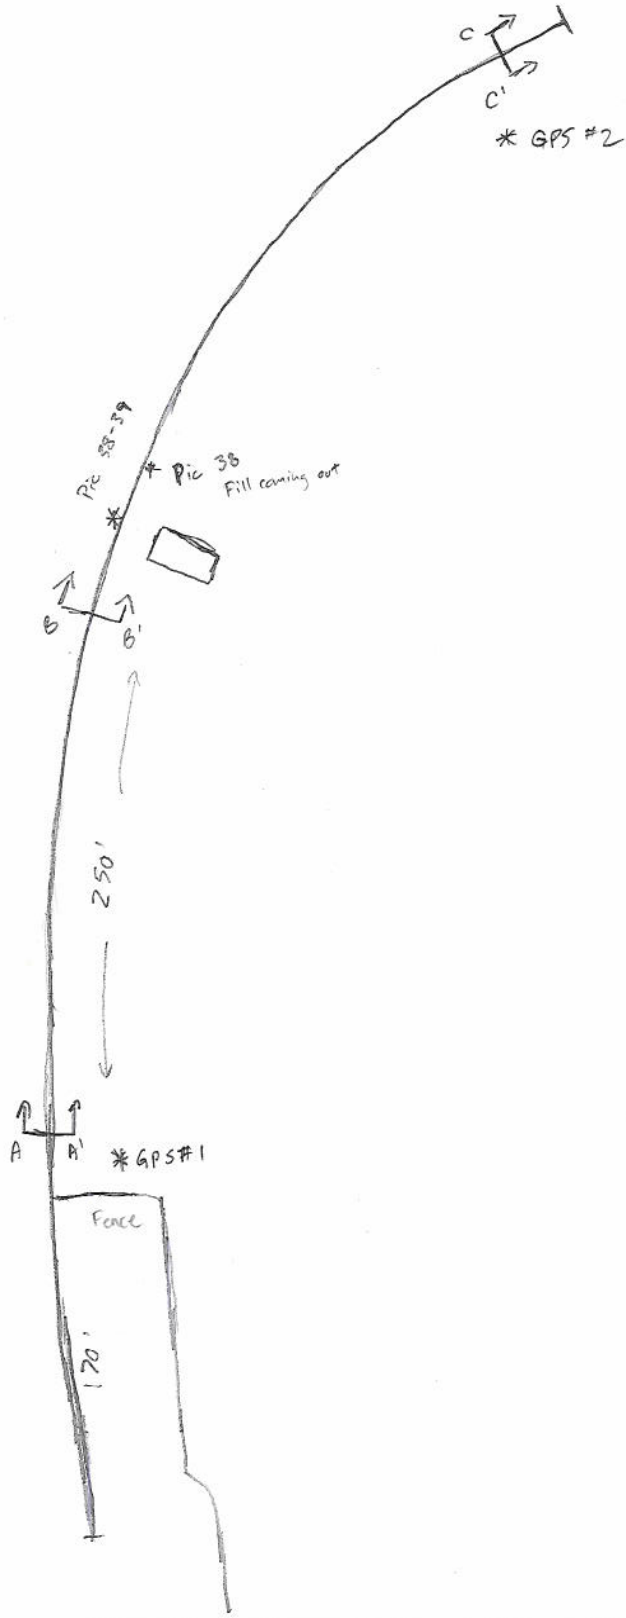
Plan View/Drainage:

- unable to access top of wall, unknown condition
- wall appears in very good condition
