STATE OF UTAH MSE WALL INSPECTION FORM

Compiled As Part of Research By The Utah Department of Transportation

MSE Wall at Bridge	Y <input checked="" type="radio"/> (N)	Bridge Number if applicable:		Wall Number	R-374-G
Surrounding Structures				Maximum Height of Wall (ft)	14 FT
Distance to Each Structure				One Stage, Two Stage or Block Wall	one stage
State Route Number				Estimated Max Length of Wall Abutment:	135 FT
Approximate Mile Marker				Max Slope of Ground in front of wall:	0
GPS Datum	WGS/84, NAD/83, or NAD/27			Max Height of wall burial line above surrounding level ground:	15 FT
MSE Wall GPS Coordinates (Location of Measurement shown on plan view)	40°21'1.41"N 111°46'3.74"W			Please draw rough layout of panel with approximate dimensions in space provided below:	
If known, Panel or System Manufacturer

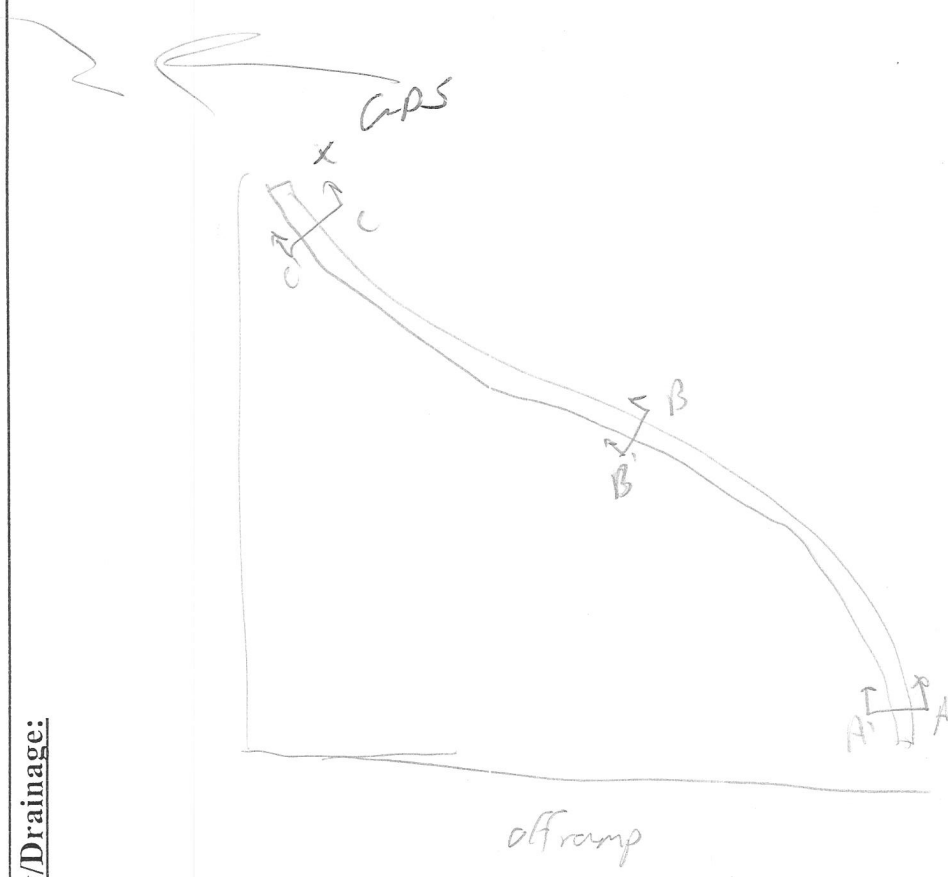
Plan View/Drainage:

a few little plants growing through the block ~~spots~~ ^{gaps}. probably a result of a lot of watering.

Against wall
