STATE OF UTAH MSE WALL INSPECTION FORM

Compiled As Part of Research By The Utah Department of Transportation

Inspection Date	8/20/07	Names Of Inspectors	Ryan Maw, Holly Griffin
Region	1	Identifying Road/Intersection	SR-89

MSE Wall at Bridge	Y	N	Bridge Number if applicable:	Wall Number	R-376
Surrounding Structures				Maximum Height of Wall (ft)	varies
Distance to Each Structure				One Stage, Two Stage or Block Wall	block walls
State Route Number			SR-89	Estimated Max Length of Wall Abutment	varies
Approximate Mile Marker				Max Slope of Ground in front of wall	varies
GPS Datum	WGS/84	NAD/83, or NAD/27		Max Height of wall burial line above surrounding level ground	varies
MSE Wall GPS Coordinates (Location of Measurement shown on plan view)	N 41° 49.936 W 111° 35.973				
If known, Panel or System Manufacturer	unknown

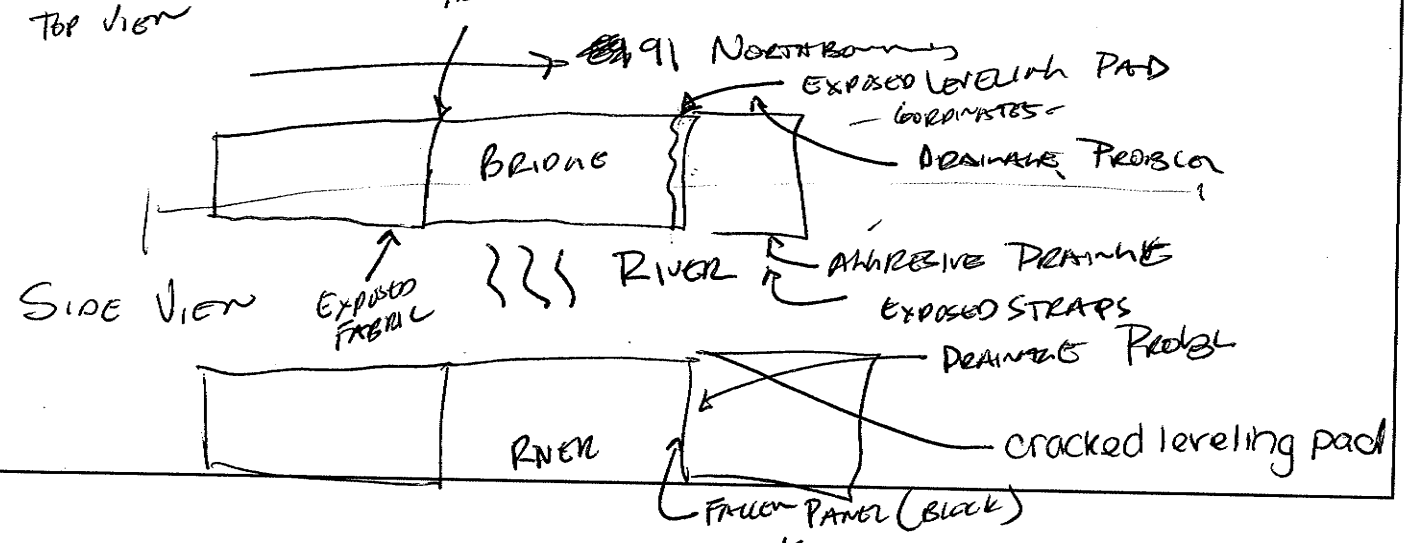
Layout and Discription:

Comments: ~~ABSEMENT/SYNOPSIS. POOR DRAINAGE ALONG SIDES & ABUTMENT OF WALLS~~
