STATE OF UTAH MSE WALL INSPECTION FORM

Compiled As Part of Research By The Utah Department of Transportation

Inspection Date	8/20/07	Names Of Inspectors	Ryan Maw, Holly Griffin
Region	1	Identifying Road/Intersection	SR-89 - Logan Canyon

Inspection Date	7/9/07	Names Of Inspectors	Ryan Maw, Holly Griffin
Region	1	Identifying Road/Intersection	Twin bridges - Moan canyon

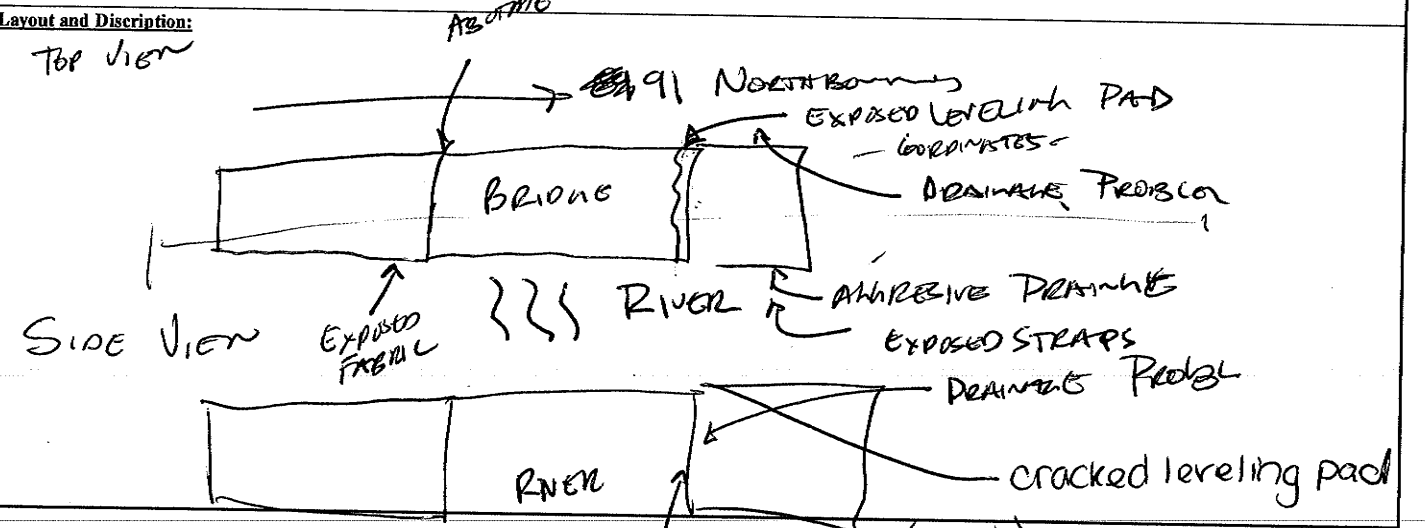
Comments: Absentment/synopsis. Poor drainage along sides & Abutment of wall.
to indicate the
