STATE OF UTAH MSE WALL INSPECTION FORM

Compiled As Part of Research By The Utah Department of Transportation

Inspection Date	8/20/07	Names Of Inspectors	Ryan Maw, Holly Griffin
Region	1	Identifying Road/Intersection	US-89 MP 472-475

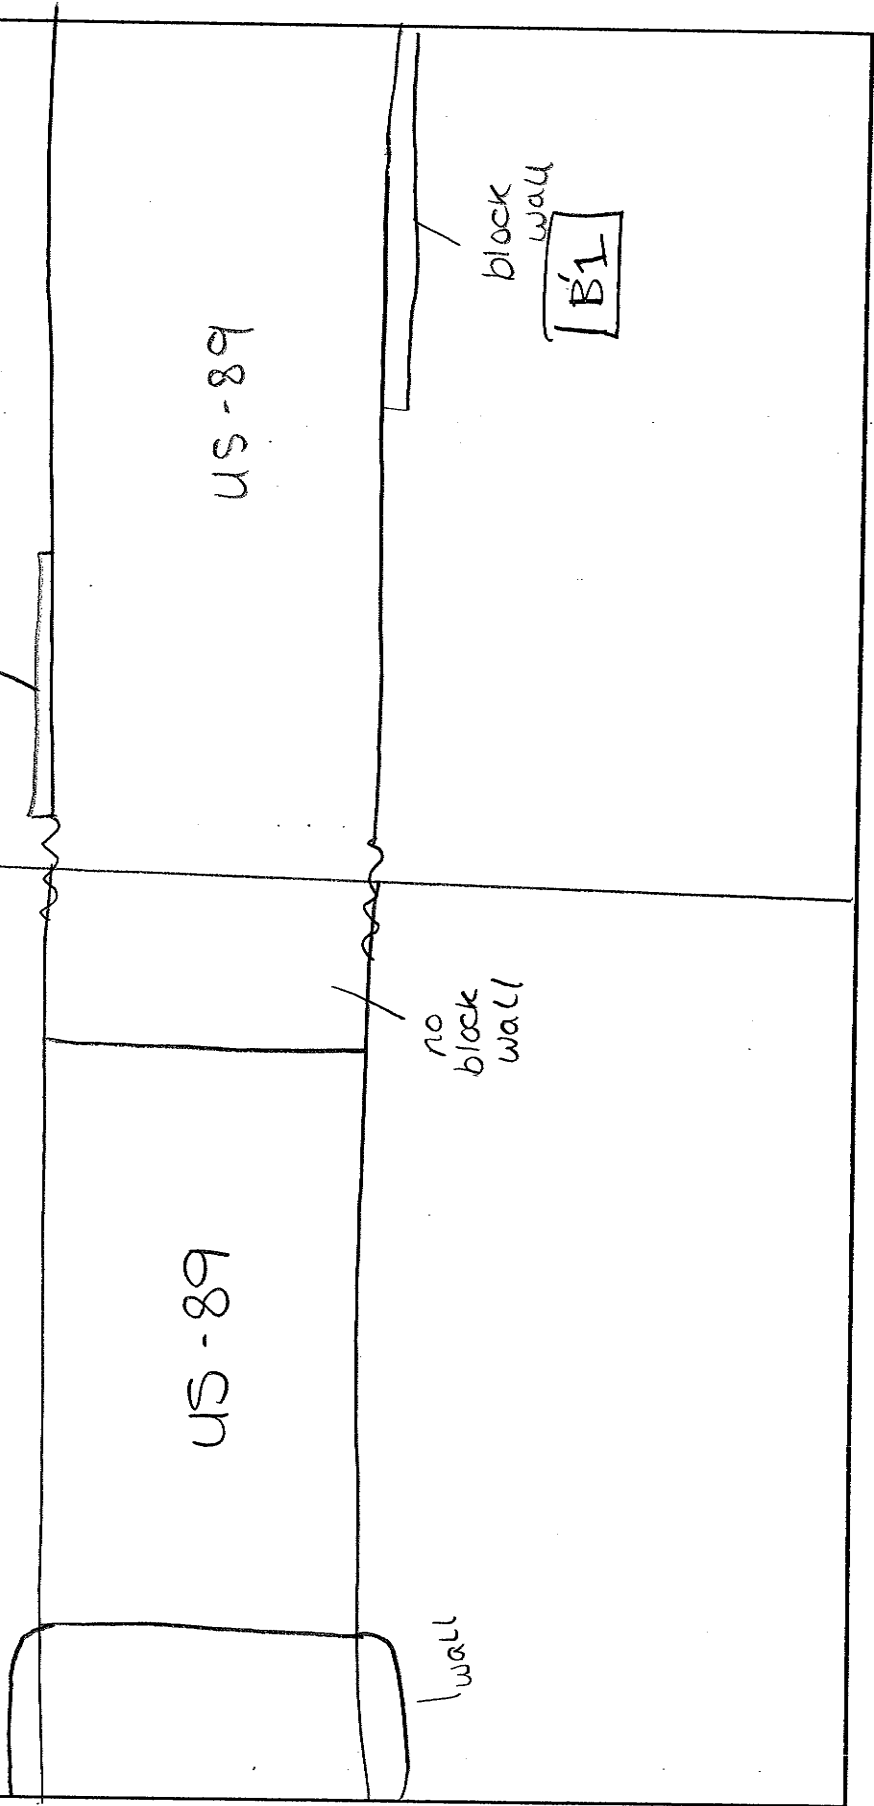
Plan View/Drainage:

WALL A' HAS SIGNIFICANT EROSION ALONG ITS WIND WALL LEADING TO BOWING. THE SLOPE WAS VERY STEEP GREATER THAN 1:5 TO 1 BELOW THE WALL. THE BLOCKS HAD SEPERATED FROM THE ABUTMENT UP TO 1.5 INCHES.

WALL B' - WAS IN GOOD CONDITION WITH LIMITED PROBLEMS
