# STATE OF UTAH MSE WALL INSPECTION FORM

<b>Region</b>	4	<b>Identifying Road/Intersection</b>	I-15, Washington interchange, St. George

MSE Wall at Bridge	Y	(N)	Bridge Number if applicable:		Wall Number	R-3P3-A
Surrounding Structures					Maximum Height of Wall (ft)	13 Ft
Distance to Each Structure					One Stage, Two Stage or Block Wall	1-stage
State Route Number					Estimated Max Length of Wall Abutment:	730 Ft
Approximate Mile Marker					Max Slope of Ground in front of wall:	0
GPS Datum	WGS/84, NAD/83, or NAD/27				Max Height of wall burial line above surrounding level ground:	0
MSE Wall GPS Coordinates (Location of Measurement shown on plan view)	37° 7' 36.74" N 103° 31' 37.81" W			Please draw rough layout of panel with approximate dimensions in space provided below:		
If known, Panel or System Manufacturer

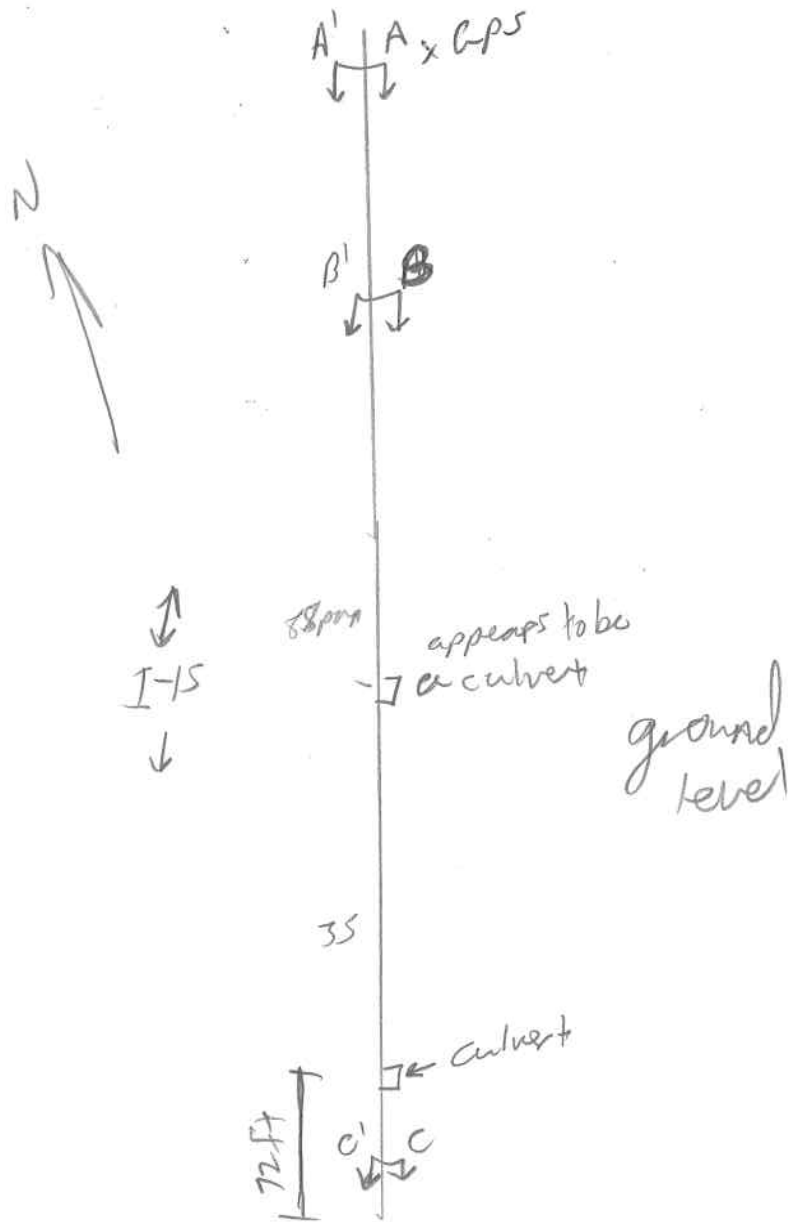
Plan View/Drainage:

possible flood detention @ toe  
 horizontal cracking along top of 50% of wall (0-0.4mm)  
 approx 3-6in below coping @ south half where wall height is less than 10 Ft. (might be from construction)
