STATE OF UTAH MSE WALL INSPECTION FORM

Compiled As Part of Research By The Utah Department of Transportation

Region	4	Identifying Road/Intersection	I-15, Washington Interchange, St George.

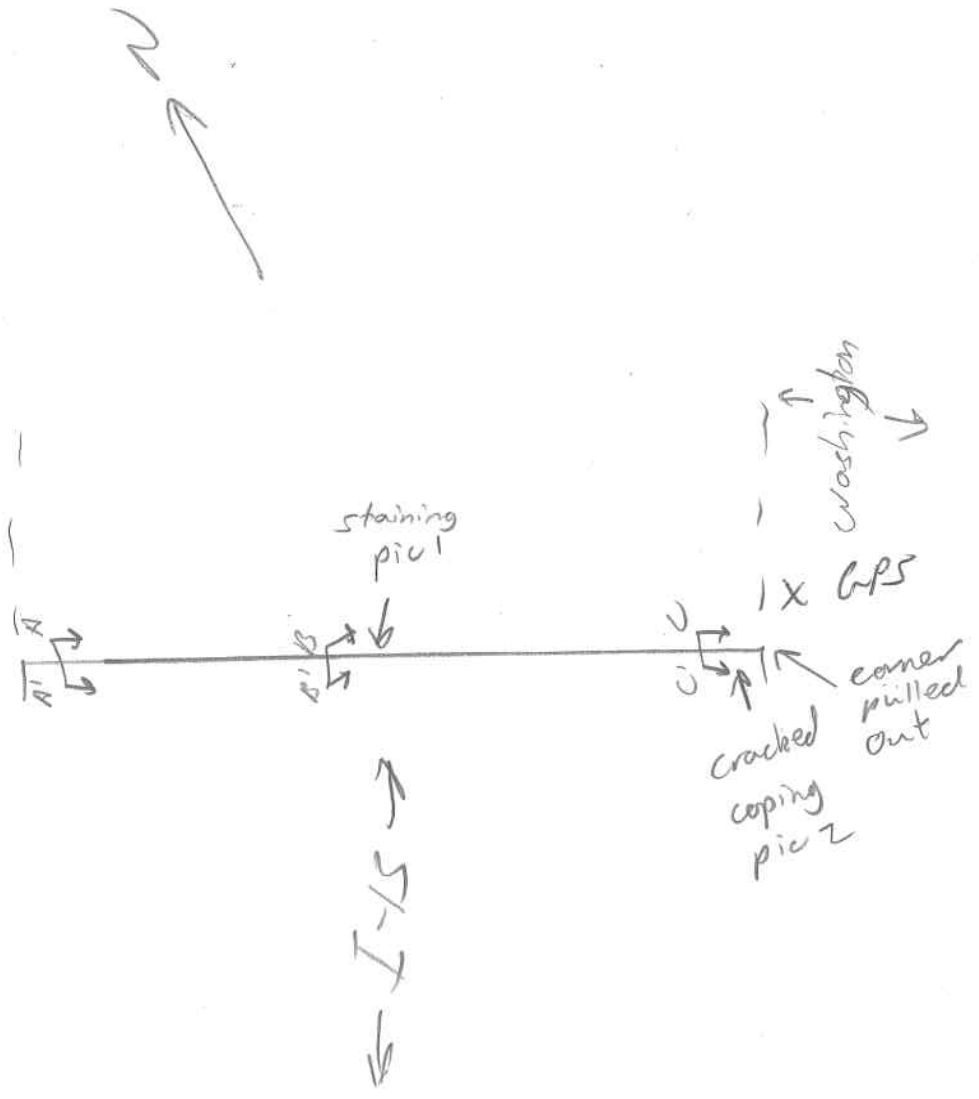
Plan View/Drainage:

Stains from water washed from bridge decking separating corner panel
