# STATE OF UTAH MSE WALL INSPECTION FORM

Compiled As Part of Research By The Utah Department of Transportation

<b>Region</b>	4	<b>Identifying Road/Intersection</b>	I-15, Washington interchange
---------------	---	--------------------------------------	------------------------------

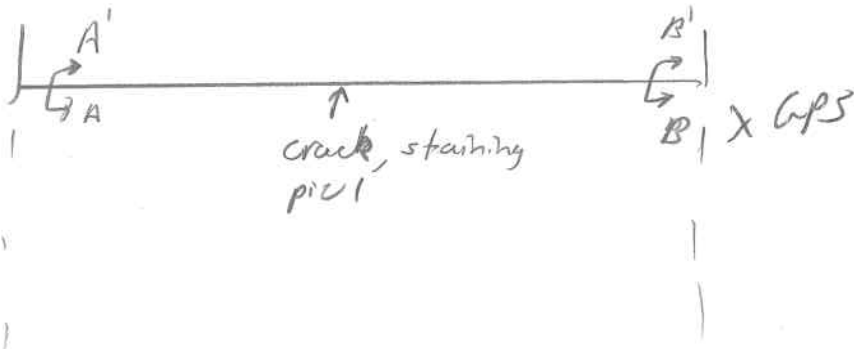
Plan View/Drainage:

some stains from middle ~~drainage~~  
drainage
