# STATE OF UTAH MSE WALL INSPECTION FORM

Compiled As Part of Research By The Utah Department of Transportation

<b>Region</b>	4	<b>Identifying Road/Intersection</b>	I-15, Washington Interchange, St. George
---------------	---	--------------------------------------	--

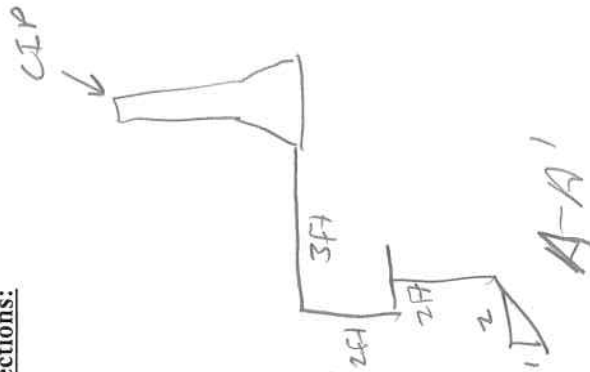
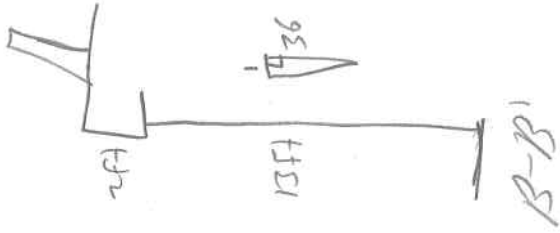
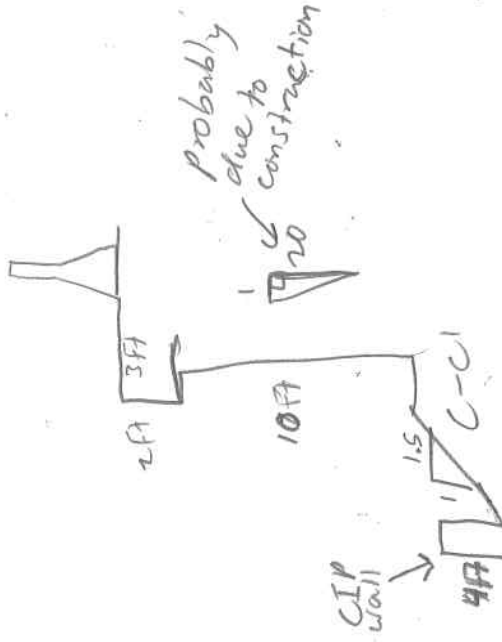
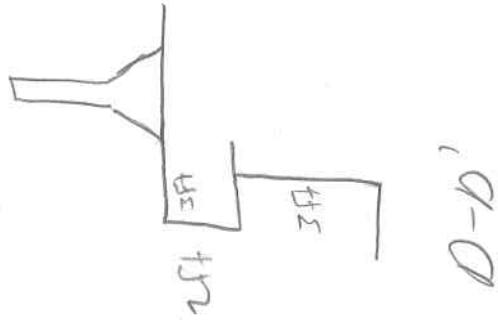
Cross Sections:

encroaching retaining wall at a clearance distance of 16' with a minimum distance of 11 ft. Wall height at narrowest portion between walls is 12 ft.

11ft  
at closest  
16 average
