STATE OF UTAH MSE WALL INSPECTION FORM

Compiled As Part of Research By The Utah Department of Transportation

Region	3	Identifying Road/Intersection
		Moark Jct, Hwy 6

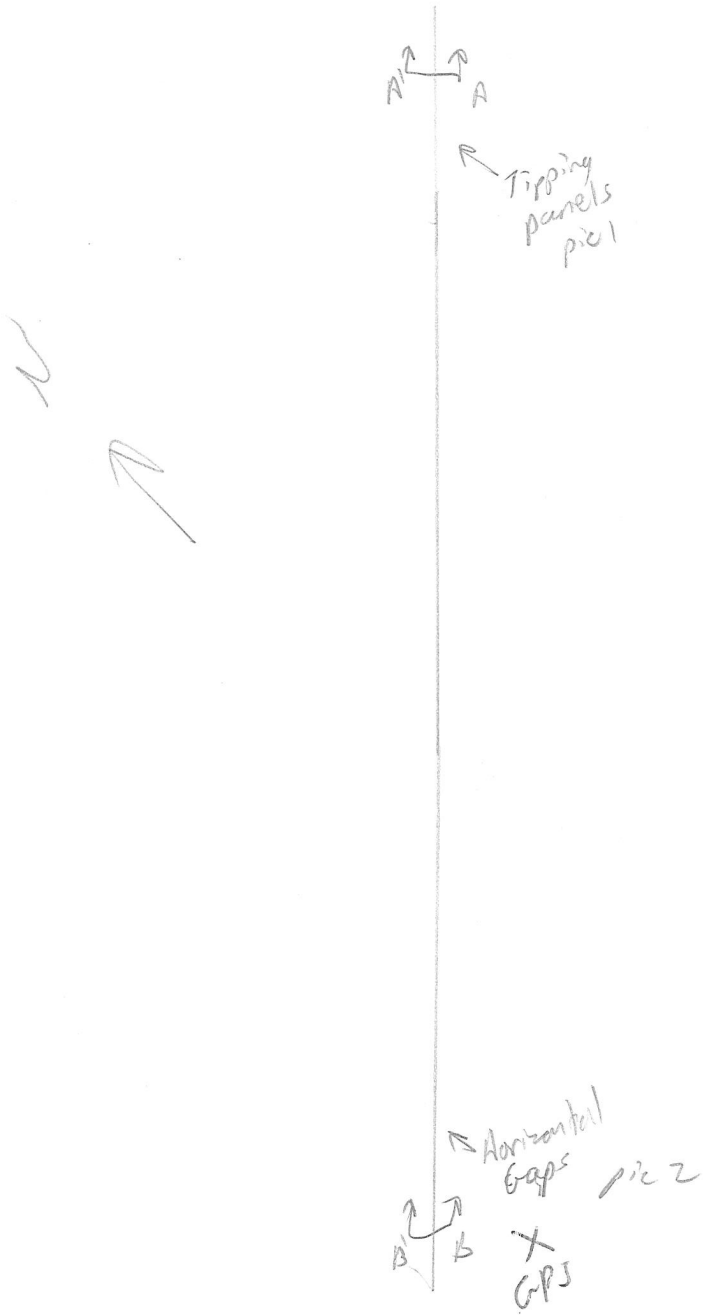
Plan View/Drainage:

Summary of Key Observations:

- separation in joints
- exposed back fill
