MSE Wall at Bridge		<input checked="" type="checkbox"/> Y	N	Bridge Number if applicable:	Wall Number	R-387-B
Surrounding Structures						
Distance to Each Structure						
State Route Number						
Approximate Mile Marker						
GPS Datum		WGS/84, NAD/83, or NAD/27				
MSE Wall GPS Coordinates (Location of Measurement shown on plan view)		40° 15' 27.27" N 110° 35' 10.77" W				
If known, Panel or System Manufacturer

Region	3	Identifying Road/Intersection	Moore St, Hwy 6
--------	---	-------------------------------	-----------------

STATE OF UTAH MSE WALL INSPECTION FORM

Compiled As Part of Research By The Utah Department of Transportation

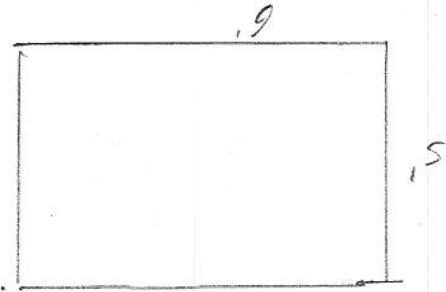
Summary of Key Observations:
 Worst of the four
~~separately copying~~ from abutment
 - cracking panels
