STATE OF UTAH MSE WALL INSPECTION FORM

Compiled As Part of Research By The Utah Department of Transportation

Region		3
Identifying Road/Intersection		
Moosh Sch. Hwy 6

MSE Wall at Bridge	<input checked="" type="checkbox"/> N	Bridge Number if applicable:		Wall Number	30 F
--------------------	---------------------------------------	------------------------------	--	-------------	------

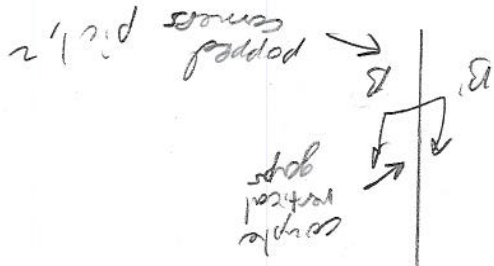
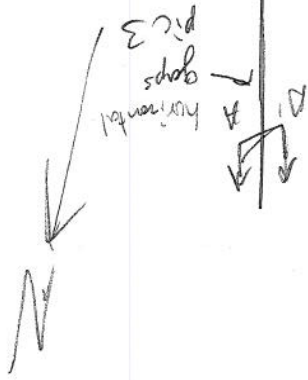
Plan View/Drainage:

Some separating of joints
