STATE OF UTAH MSE WALL INSPECTION FORM

Compiled As Part of Research By The Utah Department of Transportation

Region	4	Identifying Road/Intersection	Hwy 10 - North of Huntington
---------------	---	--------------------------------------	------------------------------

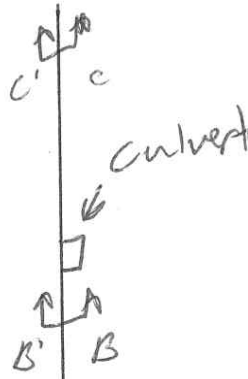
Plan View/Drainage:

Surface runoff may be a problem
