STATE OF UTAH MSE WALL INSPECTION FORM

Compiled As Part of Research By The Utah Department of Transportation

HWy 10 - North of Huntington
Region	4	Identifying Road/Intersection

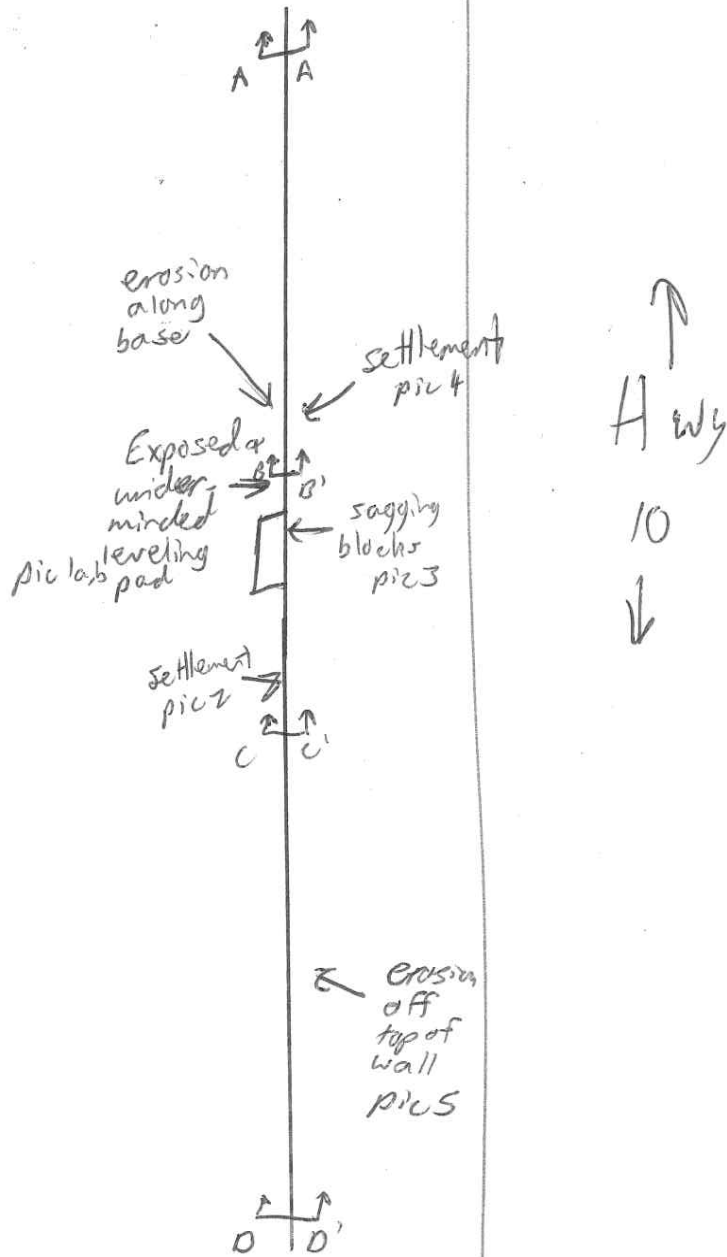
Plan View/Drainage:

Lots of erosion, wings and middle of the wall settlement due to erosion
