STATE OF UTAH MSE WALL INSPECTION FORM

Inspection Date	7/30/2007	Names Of Inspectors	HOLLY & RYAN
Region	REGION 2	Identifying Road/Intersection	I-80 & SR 189

MSE Wall at Bridge	<input checked="" type="radio"/> Y <input type="radio"/> N	Bridge Number if applicable:	C-89B	Wall Number	R-409
Surrounding Structures					
Distance to Each Structure					
State Route Number	I-80 / SR 189				
Approximate Mile Marker	147				
GPS Datum	WGS/84, NAD/83, or NAD/27				
MSE Wall GPS Coordinates (Location of Measurement shown on plan view)	N. 40° 43.832'				
	W. 111° 21.892'				
If known, Panel or System Manufacturer

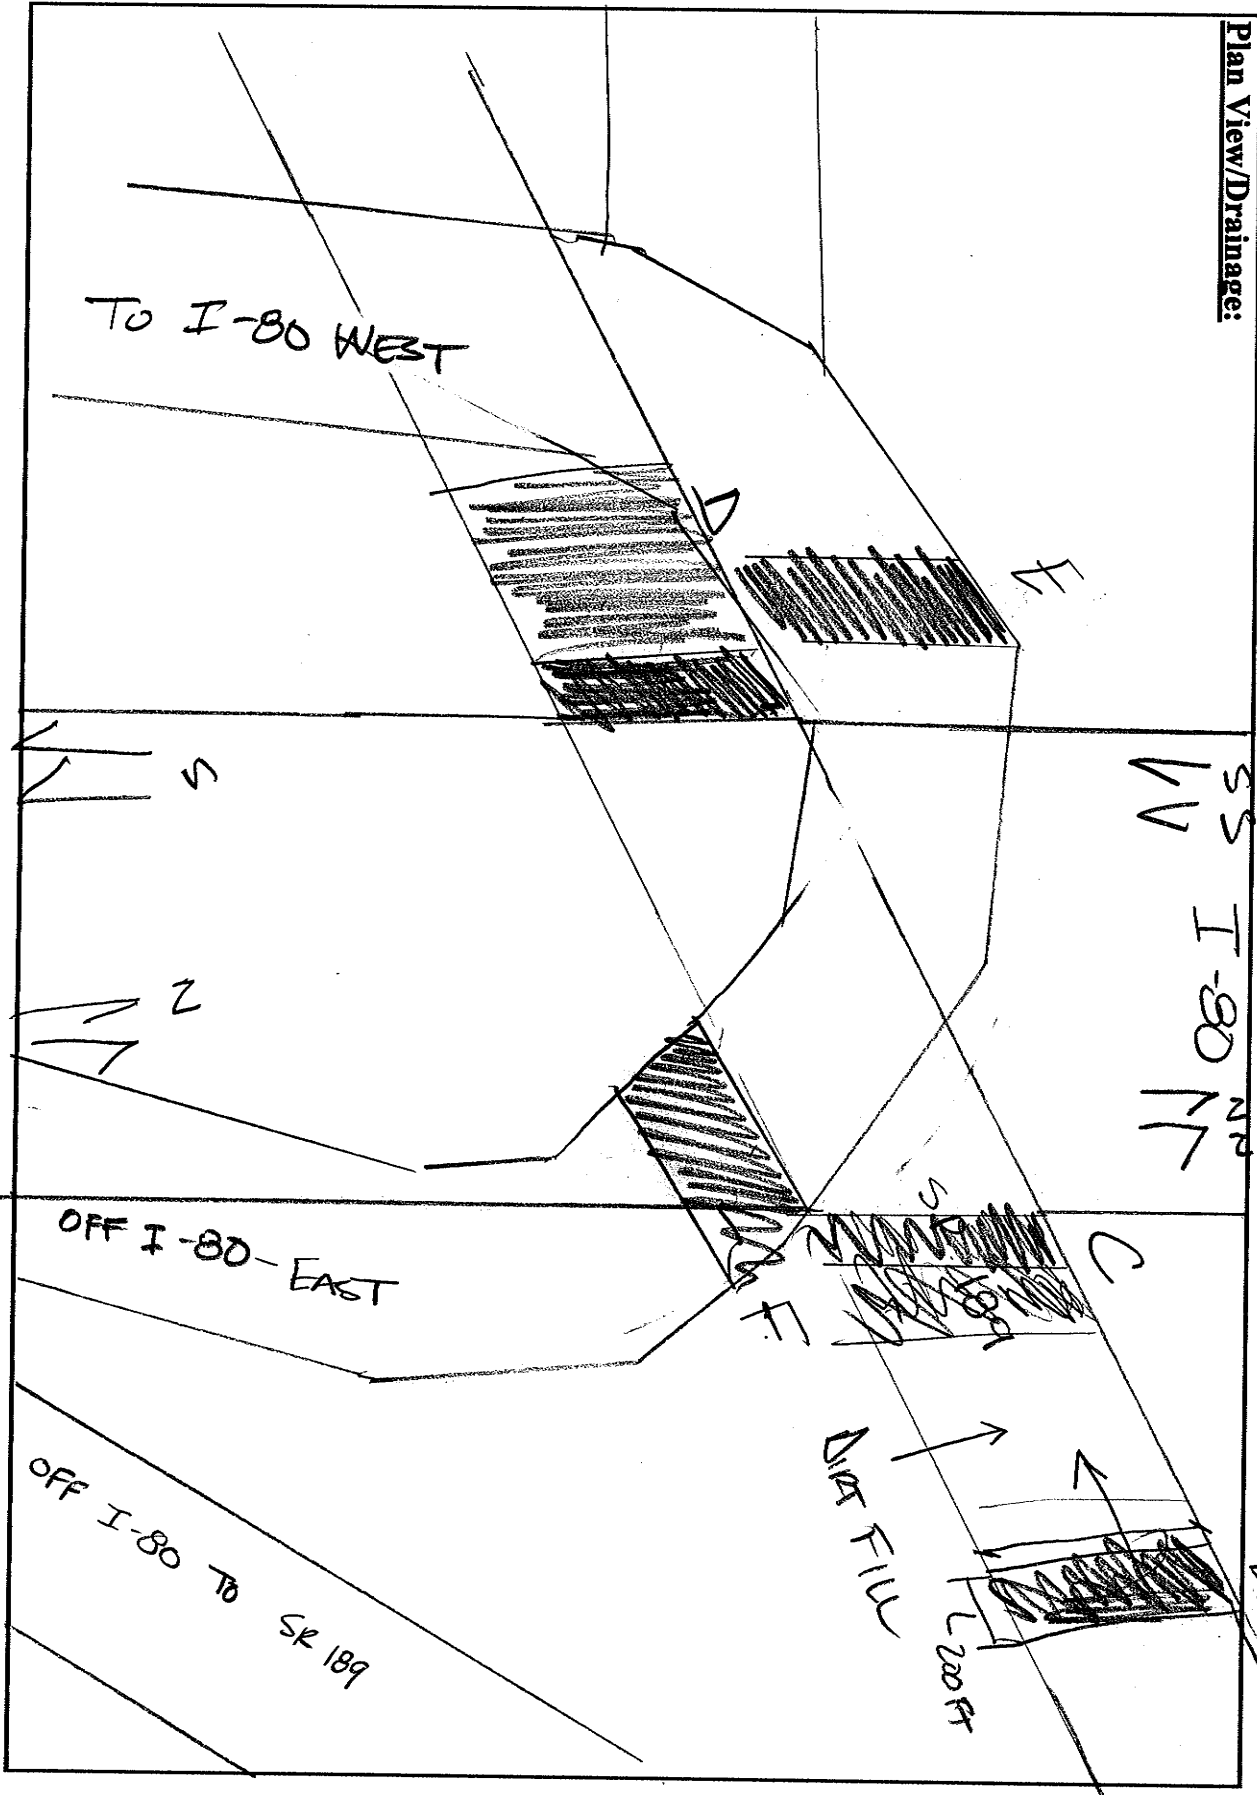
Plan View/Drainage:

TO I-80 WEST

SS I-80 RT

OFF I-80 EAST

OFF I-80 TO SR 189

DIRT FILL
200 FT

400 FT CLEAR

Co drains - 2 partial, 1 fully
