STATE OF UTAH MSE WALL INSPECTION FORM

Compiled As Part of Research By The Utah Department of Transportation

Region	Z	Identifying Road/Intersection	12300 S., I-15, SLC
--------	----------	-------------------------------	---------------------

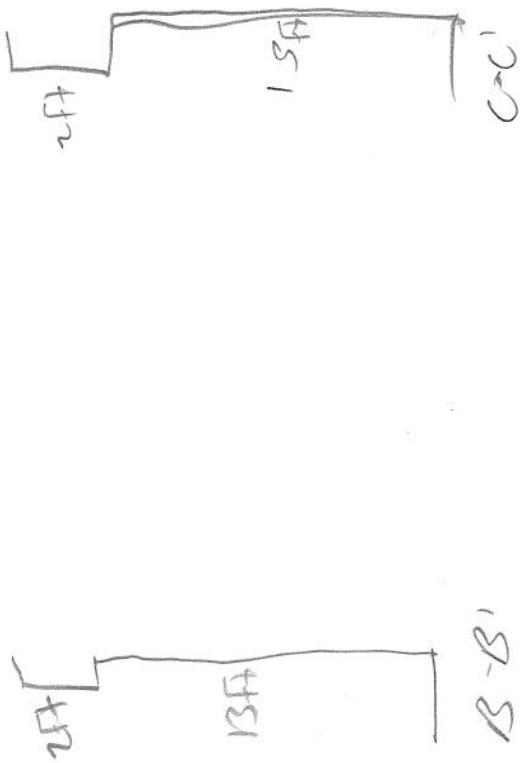
Cross Sections:

1.5 ft
