STATE OF UTAH MSE WALL INSPECTION FORM

Region	2	Identifying Road/Intersection	123005, I-15, 5LC (Draped)

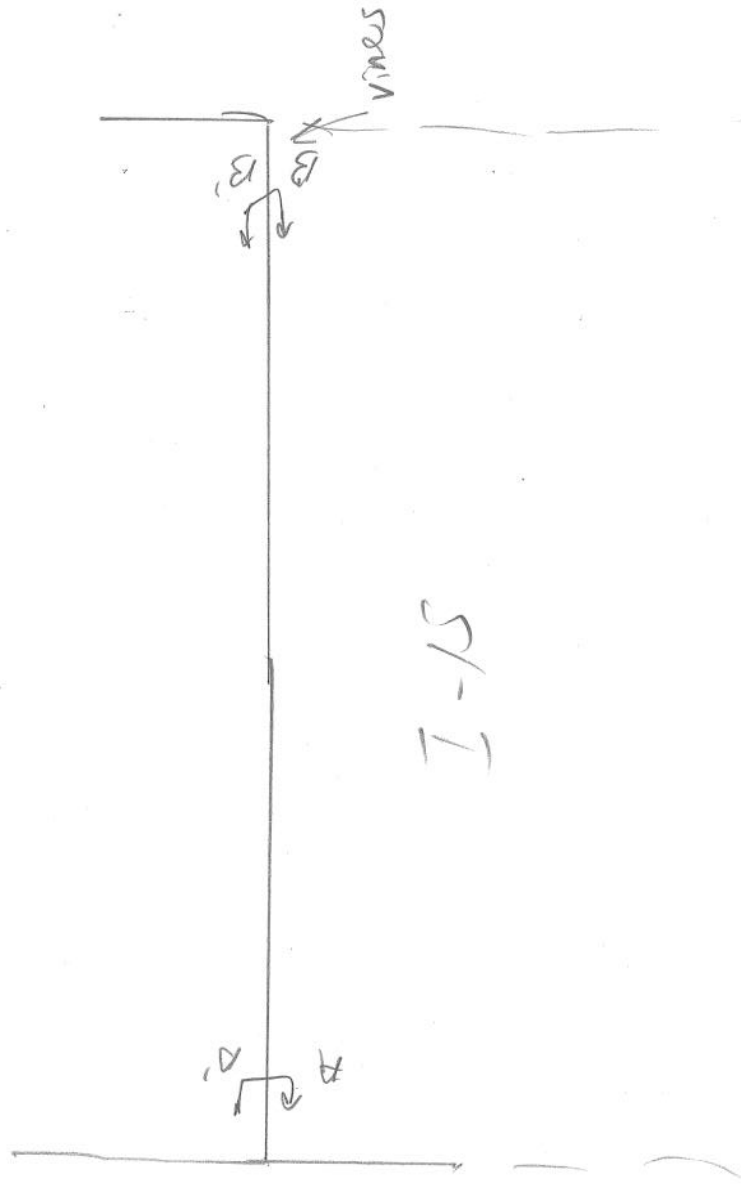
Plan View/Drainage:

Vines
